# Roof Safety Report

Runaway Bay Centre,

Prepared By: Safemaster Safety Products  
Date: 03-09-2020

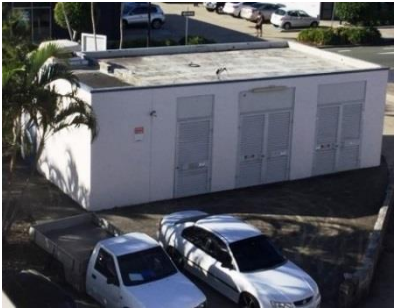
No height safety system installed (No serviceable items)	Trips, Slips and Falls	Awareness induction	High	"EWP Access only" sign to be installed	Low	Client advised	Outstanding	OH&S REGULATIONS 3.55 & 3.11
176	Building: Pet Stock Location Reference: <a href="#">L174</a> Task: Access to the roof

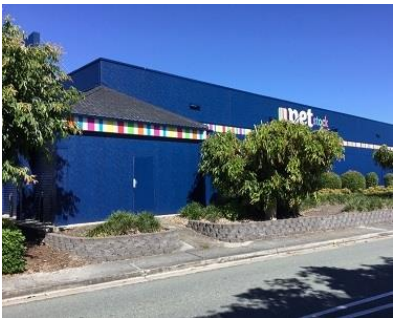
No height safety system installed and no safe access provided	Trips, Slips and Falls	Awareness induction	High	Roof access ladder, Fall arrest anchors, anchor strop and signage to be installed	Low	Client advised	Outstanding	OH&S REGULATIONS 3.55 & 3.7  AS/NZS 1657-2013 3.1.4

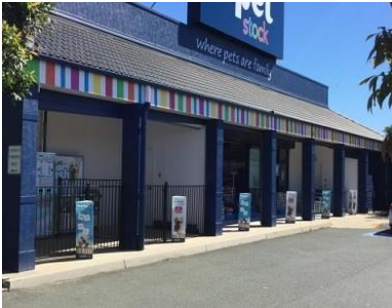
No height safety system installed (No serviceable items on roof)	Trips, Slips and Falls	Awareness induction	High	"EWP Access Only" signs to be installed	Low	Client advised	Outstanding	OH&S REGULATIONS 3.55 & 3.11
178	Building: General Stores Location Reference: <a href="#">L176</a> Task: Restrict access to the roof

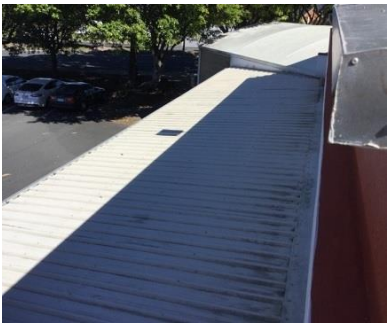
No height safety system installed (No serviceable items on roof)	Trips, Slips and Falls	Awareness induction	High	"EWP Access Only" signs to be installed	Low	Client advised	Outstanding	OH&S REGULATIONS 3.55 & 3.11

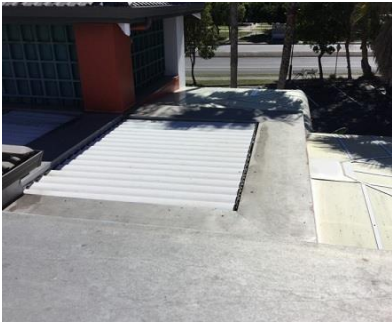
No height safety system installed (No serviceable items on roof)	Trips, Slips and Falls	Awareness induction	High	"EWP Access Only" signs to be installed	Low	Client advised	Outstanding	OH&S REGULATIONS 3.55 & 3.11
180	Building: General Stores Location Reference: <a href="#">L178</a> Task: Access to the A/c unit

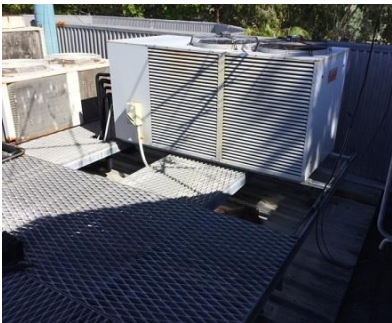
No safe access to the A/c unit	Trips, Slips and Falls	Awareness induction	Med	Gap to be filled with gratings	Low	Client advised	Outstanding	OH&S REGULATIONS 3.7

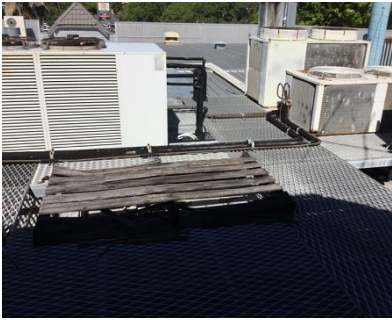
No safe access to the A/c unit	Trips, Slips and Falls	Awareness induction	Med	Gap to be filled with gratings	Low	Client advised	Outstanding	OH&S REGULATIONS 3.7
182	Building: General Stores Location Reference: <a href="#">L178</a> Task: Access to the A/c unit

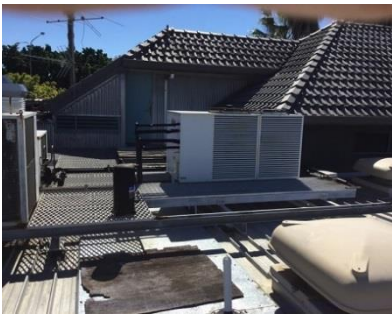
No safe access to the A/c unit	Trips, Slips and Falls	Awareness induction	Med	Gap to be filled with gratings	Low	Client advised	Outstanding	OH&S REGULATIONS 3.7

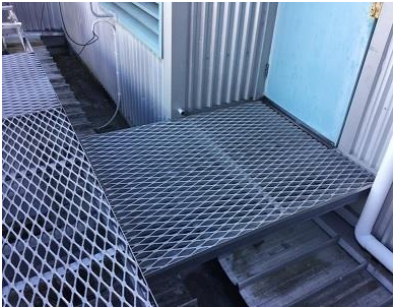
Variation in height between plantdeck and roof is greater than required maximum	Trips, Slips and Falls	Awareness induction	Med	Aluminium guardrail around plant deck including nitrile separation to be installed	Low	Client advised	Outstanding	OH&S REGULATIONS 3.6  AS/NZS 1657-2013 4.4
184	Building: General Stores Location Reference: <a href="#">L178</a> Task: Access to the roof

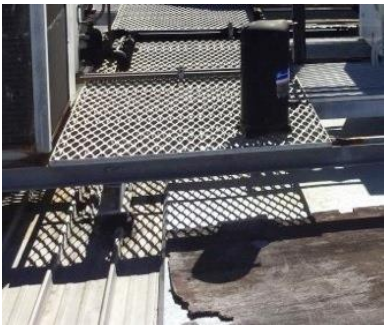
Variation in height between plantdeck and roof is greater than required maximum	Trips, Slips and Falls	Awareness induction	Med	Aluminium step up to be installed	Low	Client advised	Outstanding	OH&S REGULATIONS 3.7  AS/NZS 1657-2013 3.1.4

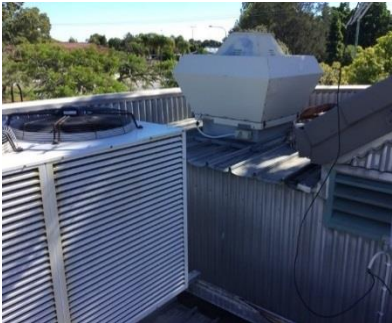
Variation in height between two roofs are greater than required minimum	Trips, Slips and Falls	Awareness induction	Med	Access ladder including handrails to be installed	Low	Client advised	Outstanding	OH&S REGULATIONS 3.7  AS/NZS 1657-2013 3.1.4
186	Building: General Stores Location Reference: <a href="#">L178</a> Task: Access to the roof

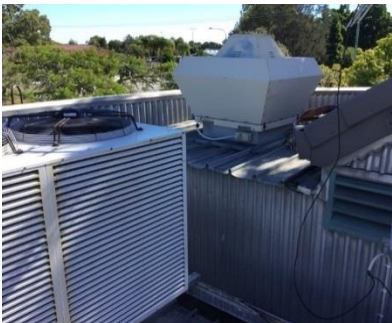
No safe access to the roof	Trips, Slips and Falls	Awareness induction	High	Fall arrest anchor to be installed	Low	Client advised	Outstanding	OH&S REGULATIONS 3.55

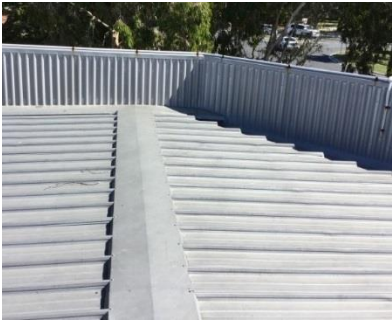
No height safety system installed	Trips, Slips and Falls	Awareness induction	High	Fall arrest anchors to be installed	Low	Client advised	Outstanding	OH&S REGULATIONS 3.55
188	Building: General Stores Location Reference: <a href="#">L185</a> Task: Access to the A/c units

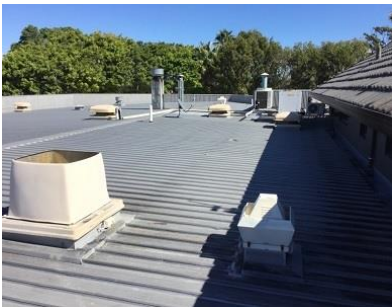
No safe access to the A/c units	Trips, Slips and Falls	N/A	Low	Supply walkway to the A/c units	Low	Client advised	Outstanding	-

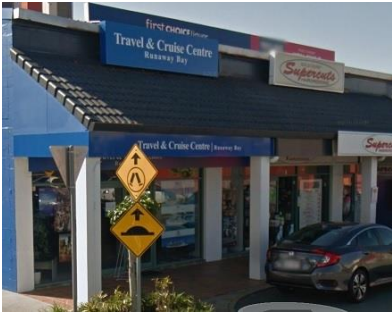
No height safety system installed (No serviceable items)	Trips, Slips and Falls	Awareness induction	High	"EWP Access only" signs to be installed	Low	Client advised	Outstanding	OH&S REGULATIONS 3.55 & 3.11
190	Building: General Stores Location Reference: <a href="#">L188</a> Task: Access to the roof

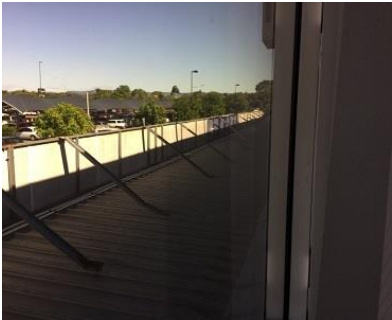
No height safety system installed	Trips, Slips and Falls	Awareness induction	High	Fall arrest anchors to be installed	Low	Client advised	Outstanding	OH&S REGULATIONS 3.55

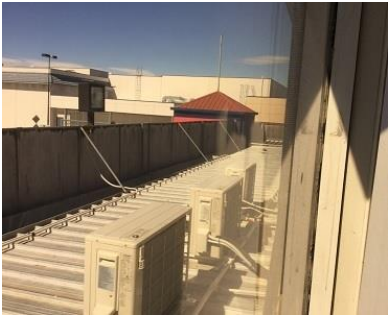
No safe access to the A/c units	Trips, Slips and Falls	N/A	Low	Supply walkway to the A/c units	Low	Client advised	Outstanding	-
192	Building: General Stores Location Reference: <a href="#">L190</a> Task: Access to the roof

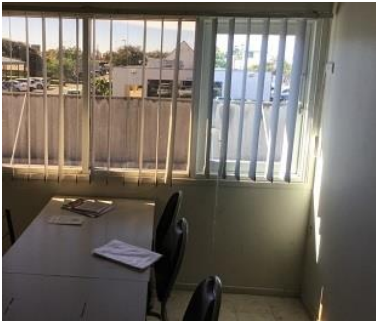
Roof access window not able to use and headroom is less than required minimum	Trips, Slips and Falls	Awareness induction	Med	"No Access" sign to be installed	Low	Client advised	Outstanding	OH&S REGULATIONS 3.7  AS/NZS 1657-2013 3.1.5

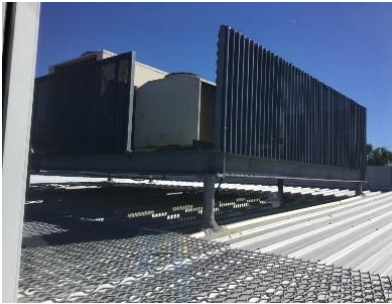
Variation in height between plant deck and roof is greater than required maximum	Trips, Slips and Falls	Awareness induction	Med	Aluminium single step up to be installed	Low	Client advised	Outstanding	OH&S REGULATIONS 3.7  AS/NZS 1657-2013 3.1.4
194	Building: General Stores Location Reference: <a href="#">L192</a> Task: Restrict access to the roof

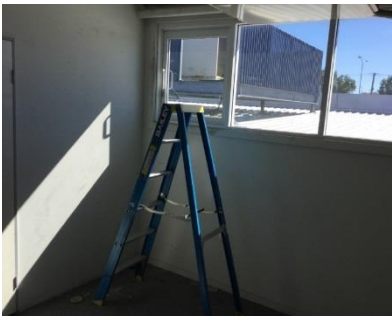
Roof access window not able to use and headroom is less than required minimum	Trips, Slips and Falls	Awareness induction	Med	"No Access" sign to be installed	Low	Client advised	Outstanding	OH&S REGULATIONS 3.7  AS/NZS 1657-2013 3.1.5

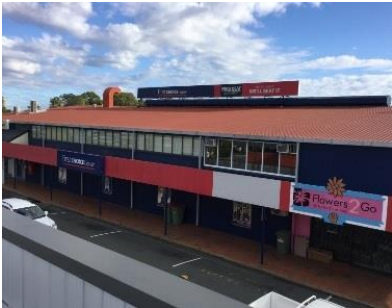
No	Photo of Hazard	Details of Hazard	Details of Risk	Existing/ Immediate Control Measure	Curren t Risk Level	Proposed Permanent Solution	Residu al Risk Assess ment	Details of Action Taken	Status	Reference
195	Building: General Stores Location Reference: <a href="#">L193</a> Task: Access to the roof

No safe access to the roof and no height safety system installed	Trips, Slips and Falls	Awareness induction	High	Ladder access bracket, Signage, permanent ladders, fall arrest anchors to be installed	Low	Client advised	Outstanding	OH&S REGULATIONS 3.7 & 3.55  AS/NZS 1657-2013 3.1.4
196	Building: General Stores Location Reference: <a href="#">L194</a> Task: Access to the roof

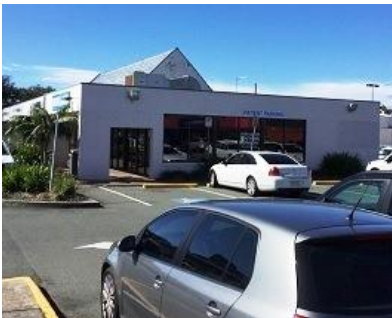
No safe access to the roof and no height safety system installed	Trips, Slips and Falls	Awareness induction	High	Ladder access bracket, Signage, anchor strop, fall arrest anchors to be installed	Low	Client advised	Outstanding	OH&S REGULATIONS 3.55

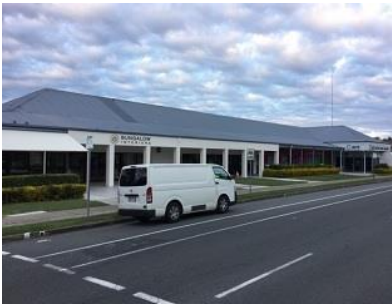
No safe access to the roof and no height safety system installed	Trips, Slips and Falls	Awareness induction	High	Ladder access bracket, Signage, anchor strop, fall arrest anchors to be installed	Low	Client advised	Outstanding	OH&S REGULATIONS 3.55
198	Building: General Stores Location Reference: <a href="#">L196</a> Task: Access to the roof

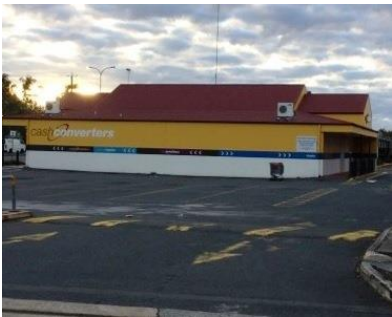
No safe access to the roof and no height safety system installed	Trips, Slips and Falls	Awareness induction	High	Ladder access bracket, Signage, anchor strop, fall arrest anchors to be installed	Low	Client advised	Outstanding	OH&S REGULATIONS 3.55

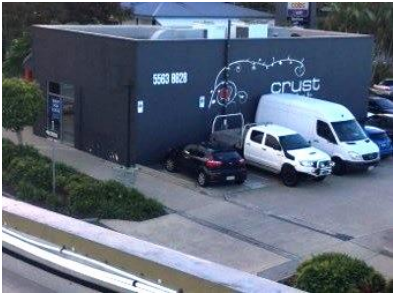
No safe access to the roof and no height safety system installed	Trips, Slips and Falls	Awareness induction	High	Ladder access bracket, Signage, anchor strop, access ladder, fall arrest anchors to be installed	Low	Client advised	Outstanding	OH&S REGULATIONS 3.55
200	Building: General Stores Location Reference: <a href="#">L198</a> Task: Access to the roof

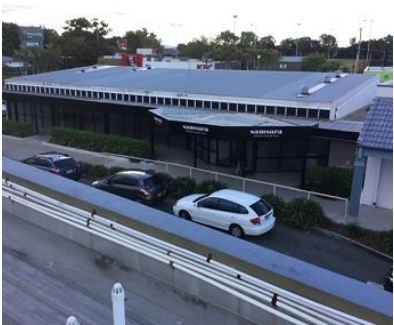
No safe access to the roof and no height safety system installed	Trips, Slips and Falls	Awareness induction	High	Ladder access bracket, Signage, anchor strop, access ladders, fall arrest anchors to be installed	Low	Client advised	Outstanding	OH&S REGULATIONS 3.55

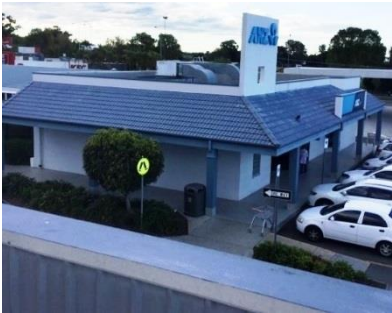
No height safety system installed (No serviceable items)	Trips, Slips and Falls	Awareness induction	High	"EWP Access only" signs to be installed	Low	Client advised	Outstanding	OH&S REGULATIONS 3.55 & 3.11
202	Building: General Stores Location Reference: <a href="#">L200</a> Task: Access to the roof

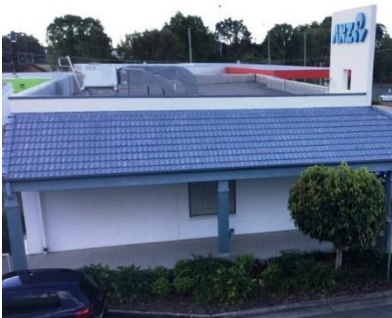
No height safety system installed	Trips, Slips and Falls	Awareness induction	High	Anchor strop and Fall arrest anchors to be installed	Low	Client advised	Outstanding	OH&S REGULATIONS 3.55

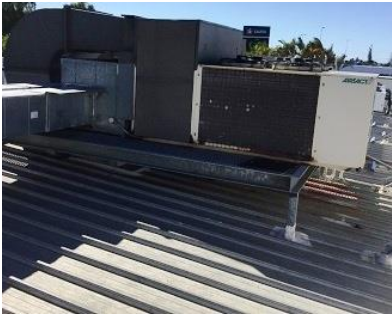
No safe access to the A/c unit on plant deck	Trips, Slips and Falls	Awareness induction	Med	Access ladder, handrails and grating to be installed to fill the gap	Low	Client advised	Outstanding	OH&S REGULATIONS 3.7  AS/NZS 1657-2013 3.1.4 & 4.4
204	Building: General Stores Location Reference: <a href="#">L202</a> Task: Access to the plant deck

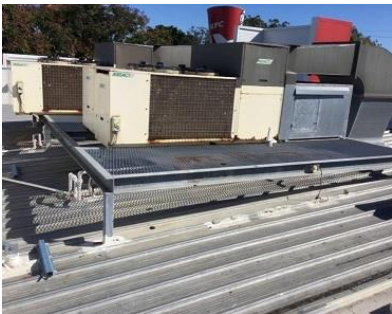
No safe access to the A/c unit on plant deck	Trips, Slips and Falls	Awareness induction	Med	Access ladder, handrails and grating to be installed to fill the gap	Low	Client advised	Outstanding	OH&S REGULATIONS 3.7  AS/NZS 1657-2013 3.1.4 & 4.4

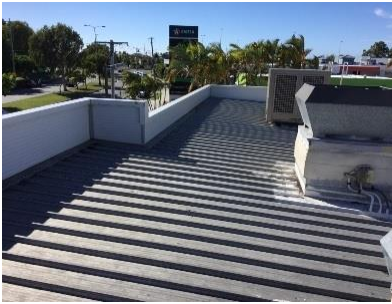
No height safety system installed	Trips, Slips and Falls	Awareness induction	High	Fall arrest anchors to be installed	Low	Client advised	Outstanding	OH&S REGULATIONS 3.55
206	Building: General Stores Location Reference: <a href="#">L206</a> Task: Access to the plant deck

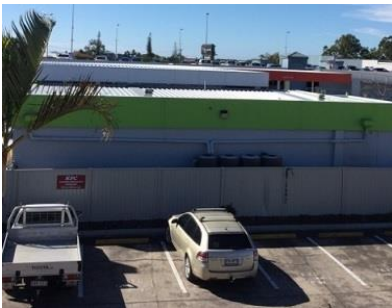
No height safety system installed	Trips, Slips and Falls	Awareness induction	High	Anchor strop, permanent ladder and Fall arrest anchors to be installed	Low	Client advised	Outstanding	OH&S REGULATIONS 3.55 & 3.7  AS/NZS 1657-2013 3.1.4

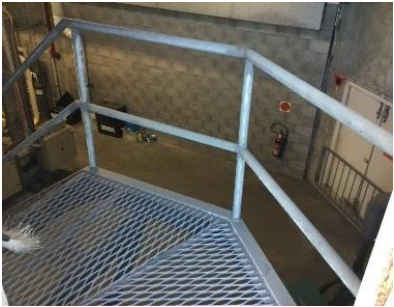
Toe board is missing at landing	Head Injury	Awareness induction	Med	Toe board including nitrile separation to be installed	Low	Client advised	Outsta nding	OH&S REGULATIONS 3.7  AS/NZS 1657-2013 4.6

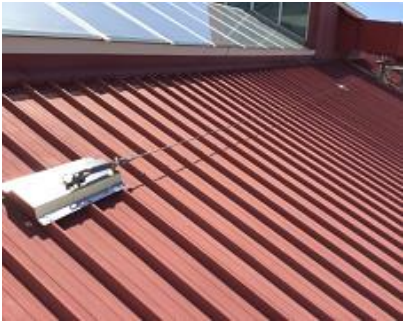
Static line over 10 years old	Trips, Slips and Falls	Awareness induction	High	Existing static lines (x6) to be replaced	Low	Client advised	Outsta nding	OH&S REGULATIONS 3.55  AS/NZS 1891.4:2009 6.3 (vi)
20 9	Building: General Stores Location Reference: <a href="#">L45</a> Task: Access to the roof

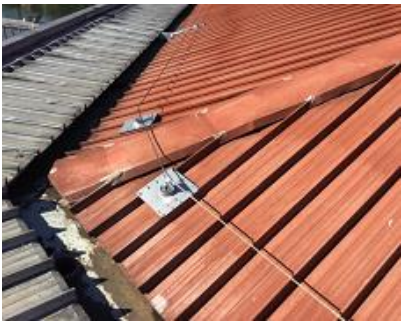
Static line over 10 years old	Trips, Slips and Falls	Awareness induction	High	Existing static lines (x6) to be replaced	Low	Client advised	Outsta nding	OH&S REGULATIONS 3.55  AS/NZS 1891.4:2009 6.3 (vi)

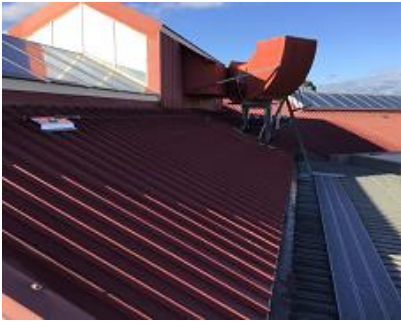
Static line over 10 years old	Trips, Slips and Falls	Awareness induction	High	Existing static lines (x2) to be replaced	Low	Client advised	Outsta nding	OH&S REGULATIONS 3.55  AS/NZS 1891.4:2009 6.3 (vi)
211	Building: General Stores Location Reference: <a href="#">L91</a> Task: Access to the roof

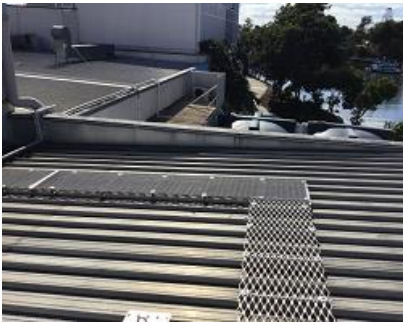
Gap between walkway and fall edge is less than required minimum	Trips, Slips and Falls	Awareness induction	Med	Handrail to be installed	Low	Client advised	Outstanding	OH&S REGULATIONS 3.7  AS/NZS 1657-2018 5.4.1
213	Building: General Stores Location Reference: <a href="#">L101</a> Task: Access to the roof

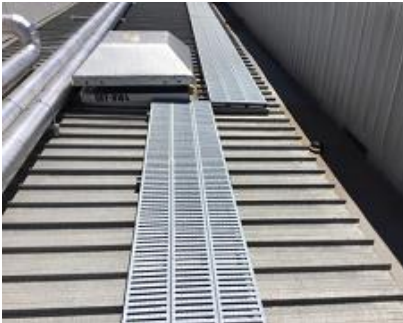
Gap between walkway panels are greater than required maximum	Trips, Slips and Falls	Awareness induction	Med	Additional walkway sections to be installed	Low	Client advised	Outstanding	OH&S REGULATIONS 3.7  AS/NZS 1657-2018 3.2.3.4

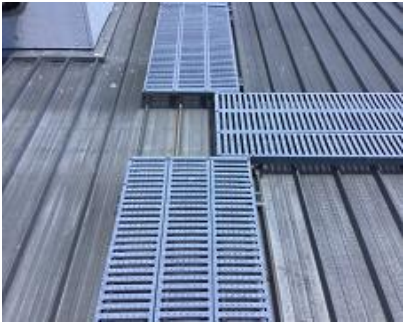
Gap between walkway panels are greater than required maximum	Trips, Slips and Falls	Awareness induction	Med	Additional walkway sections to be installed	Low	Client advised	Outstanding	OH&S REGULATIONS 3.7  AS/NZS 1657-2018 3.2.3.4
215	Building: General Stores Location Reference: <a href="#">L76</a> Task: Access to the roof

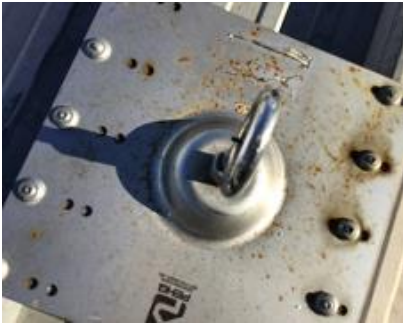
Anchor point rusted	Trips, Slips and Falls	Awareness induction	High	Existing anchor to be replaced	Low	Client advised	Outstanding	OH&S REGULATIONS 3.55

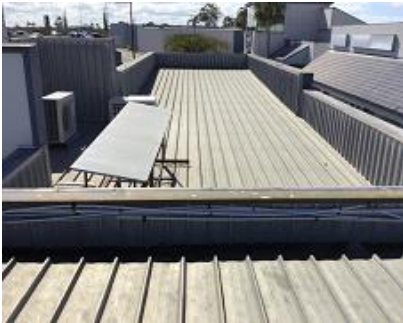
Variation in height between different roof levels	Trips, Slips and Falls	Awareness induction	Med	Access ladder to be installed	Low	Client advised	Outstanding	OH&S REGULATIONS 3.7  AS/NZS 1657-2018 3.1.4
217	Building: General Stores Location Reference: <a href="#">L111</a> Task: Access to the roof

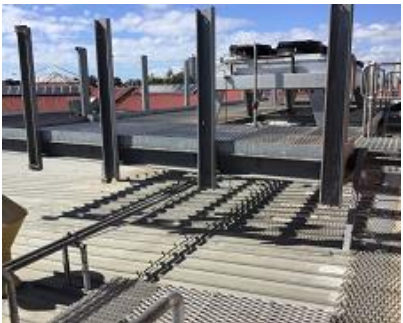
Variation in height between roof and plant deck is greater than required maximum	Trips, Slips and Falls	Awareness induction	Med	Handrail to be installed	Low	Client advised	Outstanding	OH&S REGULATIONS 3.7  AS/NZS 1657-2013 4.4

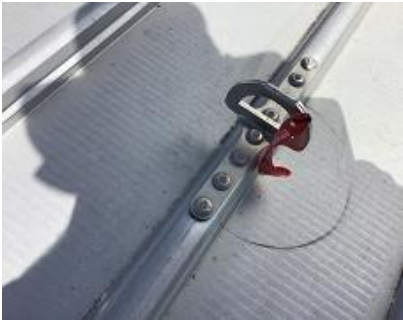
"Out of service" tagged anchors are present	Trips, Slips and Falls	Awareness induction	High	Existing anchors to be replaced (x1)	Low	Client advised	Outstanding	OH&S REGULATIONS 3.55
219	Building: General Stores Location Reference: <a href="#">L189</a> Task: Access to the roof

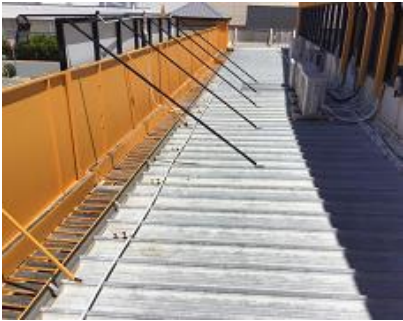
No height safety system installed	Trips, Slips and Falls	Awareness induction	High	Static line to be installed	Low	Client advised	Outstanding	OH&S REGULATIONS 3.55

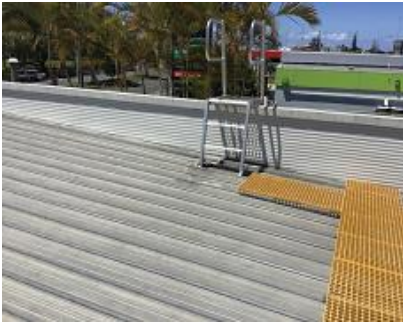
No landing platform installed at base	Trips, Slips and Falls	Awareness induction	Med	Landing to be installed	Low	Client advised	Outstanding	OH&S REGULATIONS 3.7  AS/NZS 1657-2018 3.1.4
221	Building: General Stores Location Reference: <a href="#">L204</a> Task: Access to the roof

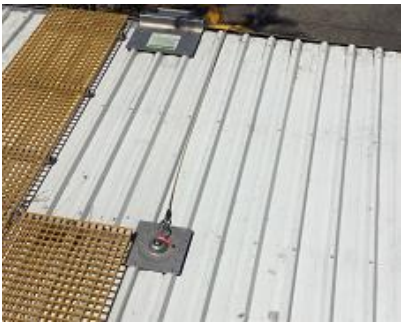
"Out of service" tagged anchors are present and anchor strop hanging over the fall edge	Trips, Slips and Falls	Awareness induction	High	Existing anchor and strop to be replaced (x1)	Low	Client advised	Outstanding	OH&S REGULATIONS 3.55
