# Roof Safety Report

**Villawood Immigration  
Detention Centre - NSW 2163**

Prepared By: Safemaster Safety Products  
Date: 20-02-2020

22-01-2020

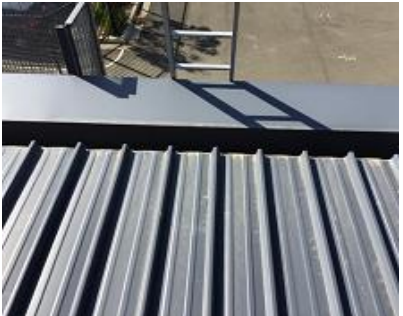
No safe access to the roof and not enough anchors installed to protect the fall edge	Trips, Slips and Falls	Awareness induction	High	Ladder access bracket, sign, parapet platform, strop and anchors to be installed	Low	Client advised	Outstanding	OH&S REGULATIONS 3.55 & 3.7  AS1657-2018 3.1.4

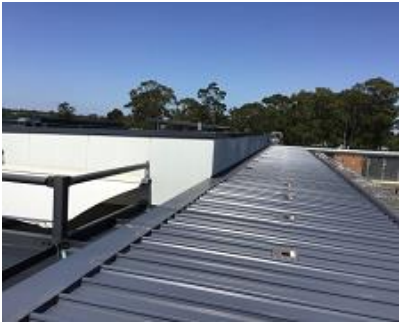
Variation in height between roofs are greater than required maximum	Trips, Slips and Falls	Awareness induction	Med	Access ladder to be installed	Low	Client advised	Outstanding	OH&S REGULATIONS 3.7  AS1657-2018 3.1.4

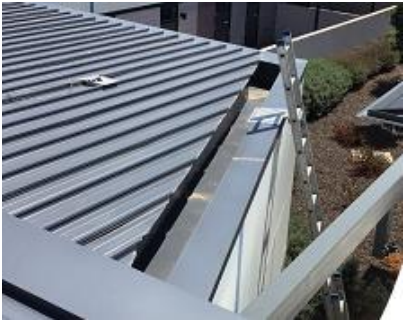
No safe access to the roof	Trips, Slips and Falls	Awareness induction	High	Ladder access bracket, sign, parapet platform and stop to be installed	Low	Client advised	Outstanding	OH&S REGULATIONS 3.55 & 3.7  AS1657-2018 3.1.4

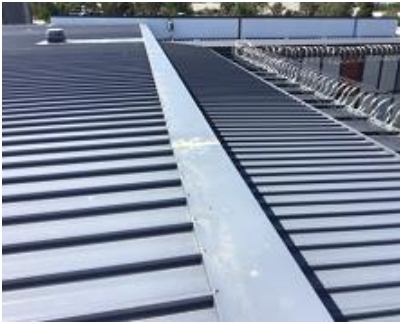
Variation in height between roofs are greater than required maximum	Trips, Slips and Falls	Awareness induction	Med	Access ladder to be installed	Low	Client advised	Outstanding	OH&S REGULATIONS 3.7  AS1657-2018 3.1.4

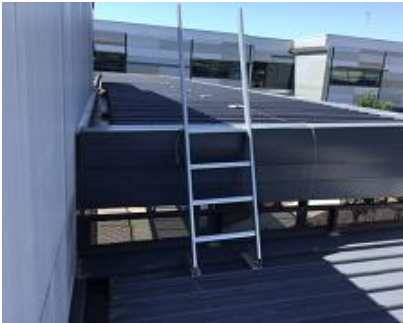
Top rung not levelled with landing and bottom rung height is less than required minimum	Trips, Slips and Falls	Awareness induction	Med	Existing ladder to be re-installed with landing platforms and brackets	Low	Client advised	Outstanding	OH&S REGULATIONS 3.7  AS1657-2018 7.4.3.3 & 7.4.3.4

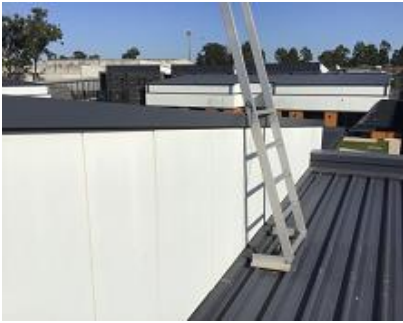
Top rung not levelled with landing and bottom rung height is less than required minimum	Trips, Slips and Falls	Awareness induction	Med	Existing ladder to be re-installed with landing platforms and brackets	Low	Client advised	Outstanding	OH&S REGULATIONS 3.7  AS1657-2018 7.4.3.3 & 7.4.3.4

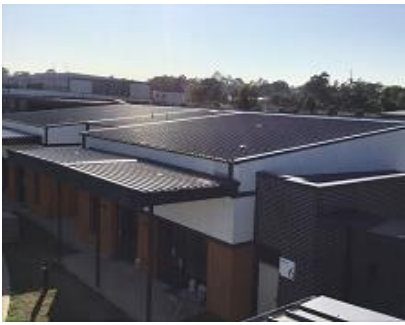
Not enough anchors installed to protect the fall edge	Trips, Slips and Falls	Awareness induction	High	Anchors to be installed	Low	Client advised	Outstanding	OH&S REGULATIONS 3.55

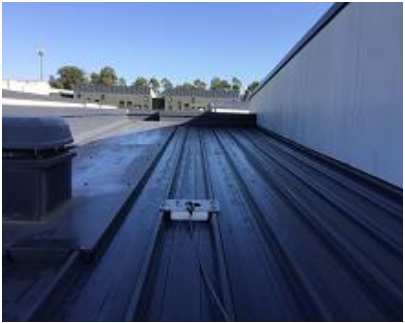
Not enough anchors installed to protect the fall edge	Trips, Slips and Falls	Awareness induction	High	Anchors to be installed	Low	Client advised	Outstanding	OH&S REGULATIONS 3.55

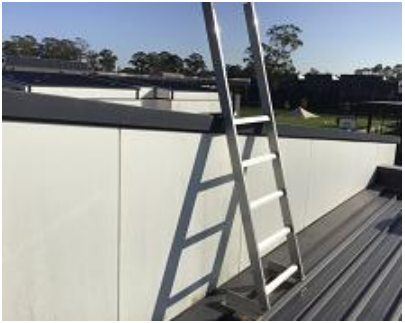
Top rung not levelled with landing and bottom rung height is less than required minimum	Trips, Slips and Falls	Awareness induction	Med	Existing ladder to be re-installed with landing platforms and brackets	Low	Client advised	Outstanding	OH&S REGULATIONS 3.7  AS1657-2018 7.4.3.3 & 7.4.3.4

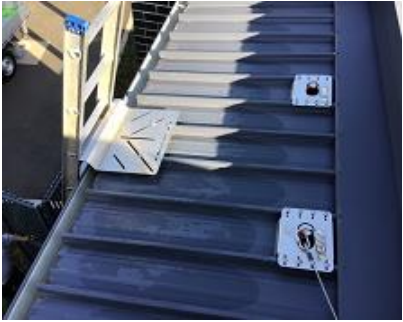
Roof sheet is too small to support anchors	Trips, Slips and Falls	Awareness induction	High	Existing systems to be removed and EWP Access only sign to be installed	Low	Client advised	Outstanding	OH&S REGULATIONS 3.55 & 3.11

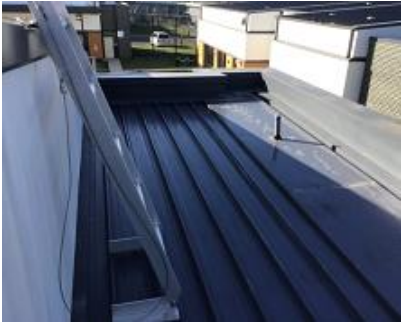
Not enough anchors installed to protect the fall edge	Trips, Slips and Falls	Awareness induction	High	Anchors to be installed	Low	Client advised	Outstanding	OH&S REGULATIONS 3.55

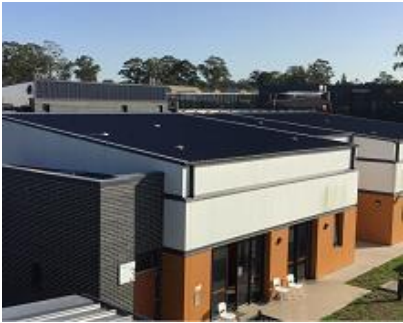
Not enough anchors installed to protect the fall edge	Trips, Slips and Falls	Awareness induction	High	Anchors to be installed	Low	Client advised	Outstanding	OH&S REGULATIONS 3.55

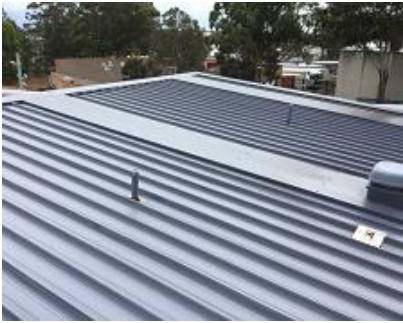
Not enough anchors installed to protect the fall edge	Trips, Slips and Falls	Awareness induction	High	Anchors to be installed	Low	Client advised	Outstanding	OH&S REGULATIONS 3.55

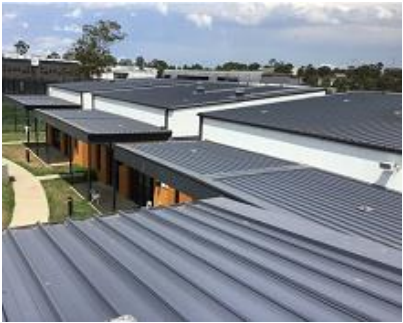
Variation in height between roofs are greater than required maximum	Trips, Slips and Falls	Awareness induction	Med	Access ladders (x3) to be installed	Low	Client advised	Outstanding	OH&S REGULATIONS 3.7  AS1657-2018 3.1.4

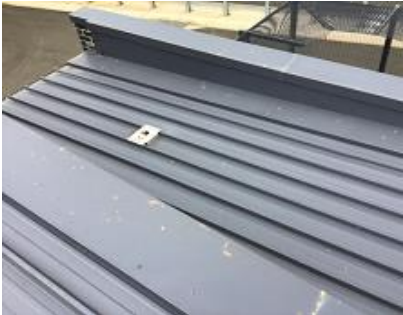
Not enough anchors installed to protect the fall edge and Variation in height between roofs are greater than required maximum	Trips, Slips and Falls	Awareness induction	High	Anchors to be installed and access ladder to be installed	Low	Client advised	Outstanding	OH&S REGULATIONS 3.7 & 3.55  AS1657-2018 3.1.4

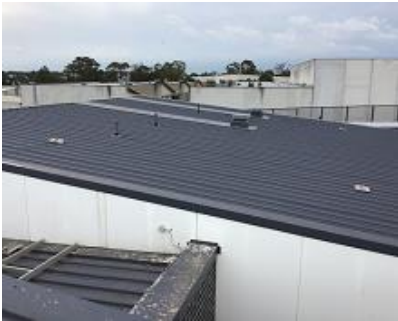
Not enough anchors installed to protect the fall edge	Trips, Slips and Falls	Awareness induction	High	Anchors to be installed	Low	Client advised	Outstanding	OH&S REGULATIONS 3.55
44	Building: General Stores Location Reference: <a href="#">L33</a> Task: Access to the roof

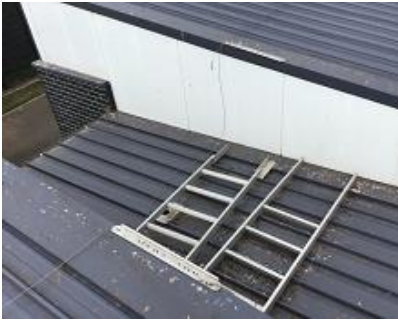
Ladders not secured and non-complaint	Trips, Slips and Falls	Awareness induction	Med	Existing ladders (x2) to be replaced	Low	Client advised	Outstanding	OH&S REGULATIONS 3.7  AS1657-2018 3.1.4

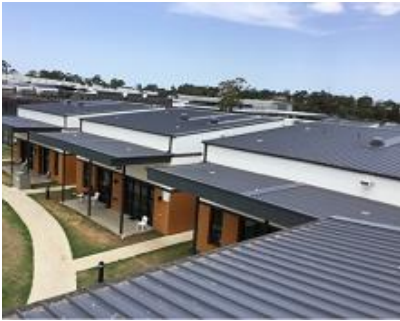
Variation in height between roofs are greater than required maximum	Trips, Slips and Falls	Awareness induction	Med	Access ladders (x3) to be installed	Low	Client advised	Outstanding	OH&S REGULATIONS 3.7  AS1657-2018 3.1.4
50	Building: General Stores Location Reference: <a href="#">L35</a> Task: Access to the roof

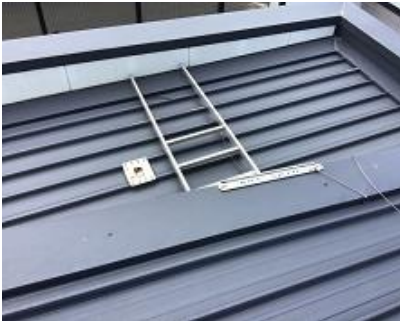
Ladders not secured and non-complaint	Trips, Slips and Falls	Awareness induction	Med	Existing ladders to be replaced	Low	Client advised	Outstanding	OH&S REGULATIONS 3.7  AS1657-2018 3.1.4

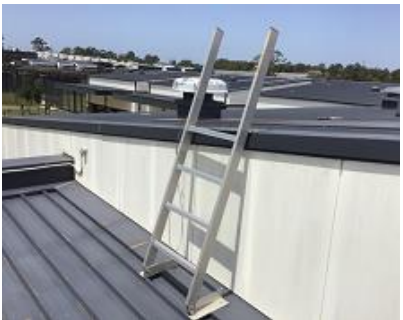
Ladders not secured and non-complaint	Trips, Slips and Falls	Awareness induction	Med	Existing ladders (x2) to be replaced	Low	Client advised	Outstanding	OH&S REGULATIONS 3.7  AS1657-2018 3.1.4

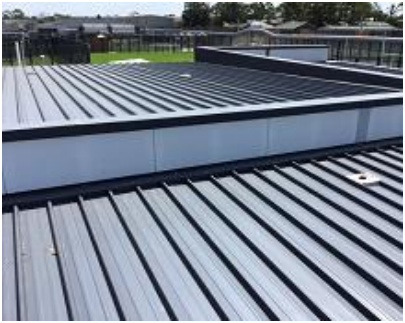
Variation in height between roofs are greater than required maximum	Trips, Slips and Falls	Awareness induction	Med	Access ladders to be installed	Low	Client advised	Outstanding	OH&S REGULATIONS 3.7  AS1657-2018 3.1.4

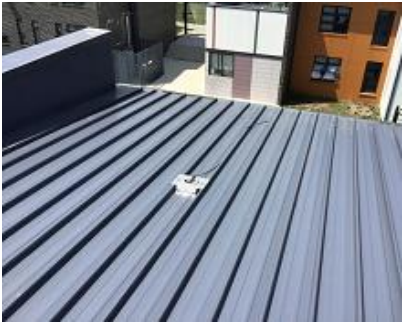
Roof access point is too high to use portable ladder	Trips, Slips and Falls	Awareness induction	High	Strop and sign to be removed. Access ladder from lower roof to be installed	Low	Client advised	Outstanding	OH&S REGULATIONS 3.55

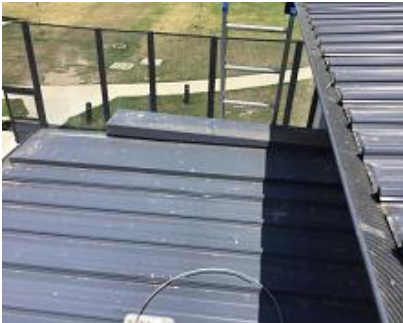
Anchor stop is not adequate and ladder bracket not installed	Trips, Slips and Falls	Awareness induction	High	Ladder bracket and stop to be installed	Low	Client advised	Outstanding	OH&S REGULATIONS 3.55

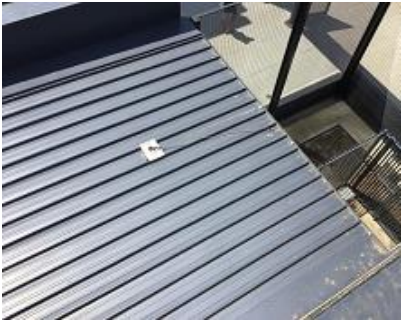
Ladder bracket and sign are not installed	Trips, Slips and Falls	Awareness induction	High	Ladder bracket and sign to be installed	Low	Client advised	Outstanding	OH&S REGULATIONS 3.55

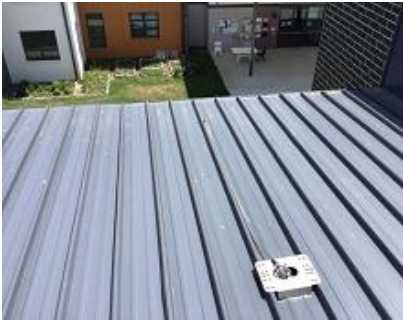
Roof access point is too high to use portable ladder	Trips, Slips and Falls	Awareness induction	High	Strop and sign to be removed. Access ladder from lower roof to be installed	Low	Client advised	Outstanding	OH&S REGULATIONS 3.55

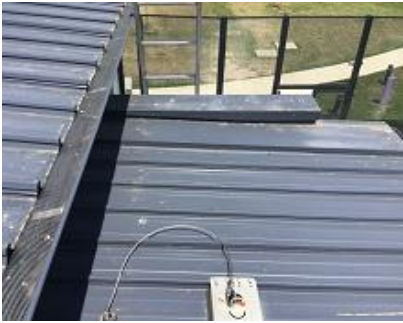
Ladder bracket not installed	Trips, Slips and Falls	Awareness induction	High	Ladder bracket to be installed	Low	Client advised	Outstanding	OH&S REGULATIONS 3.55

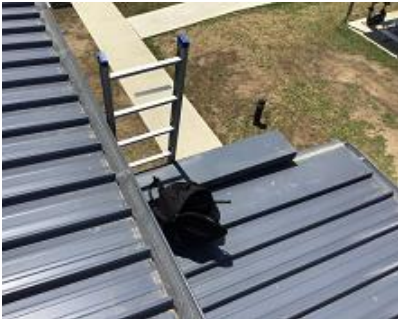
Ladder bracket not installed	Trips, Slips and Falls	Awareness induction	High	Ladder bracket to be installed	Low	Client advised	Outstanding	OH&S REGULATIONS 3.55

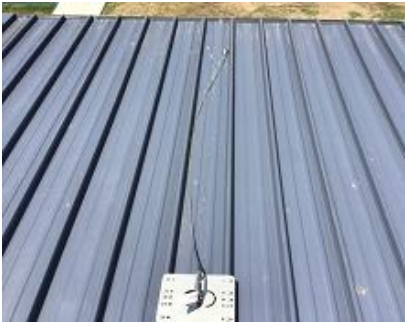
Roof access point is too high to use portable ladder	Trips, Slips and Falls	Awareness induction	High	Strop and sign to be removed. Access ladder from lower roof to be installed	Low	Client advised	Outstanding	OH&S REGULATIONS 3.55

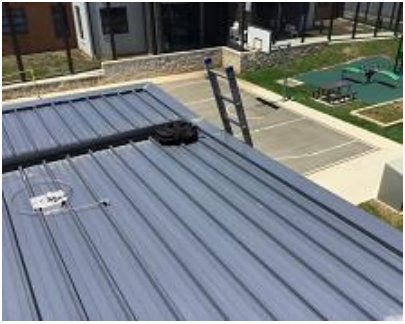
Ladder bracket not installed	Trips, Slips and Falls	Awareness induction	High	Ladder bracket to be installed	Low	Client advised	Outstanding	OH&S REGULATIONS 3.55

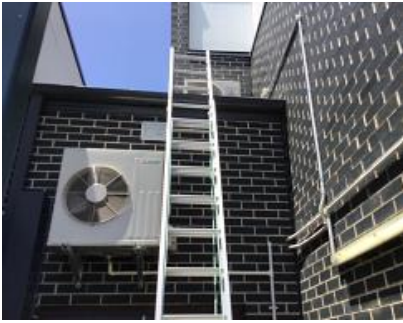
Ladder bracket not installed	Trips, Slips and Falls	Awareness induction	High	Ladder bracket to be installed	Low	Client advised	Outstanding	OH&S REGULATIONS 3.55

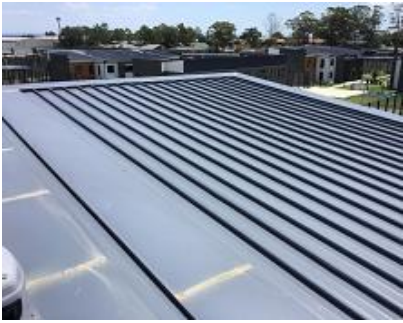
Not enough anchors installed to protect the fall edge	Trips, Slips and Falls	Awareness induction	High	Anchors to be installed	Low	Client advised	Outstanding	OH&S REGULATIONS 3.55

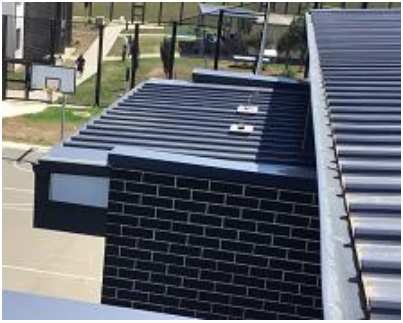
Ladder bracket not installed	Trips, Slips and Falls	Awareness induction	High	Ladder brackets to be installed	Low	Client advised	Outstanding	OH&S REGULATIONS 3.55

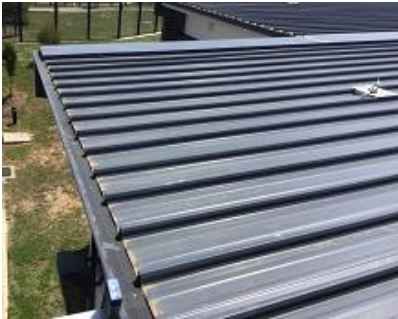
Roof access point is too high to use portable ladder	Trips, Slips and Falls	Awareness induction	High	Strop and sign to be removed. Access ladder from lower roof to be installed	Low	Client advised	Outstanding	OH&S REGULATIONS 3.55

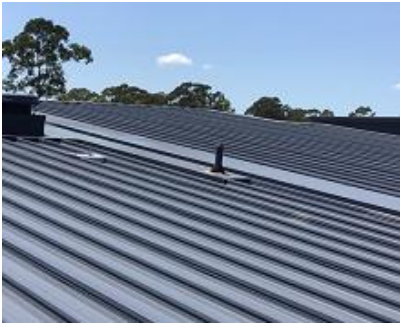
Not enough anchors installed to protect the fall edge	Trips, Slips and Falls	Awareness induction	High	Anchors to be installed	Low	Client advised	Outstanding	OH&S REGULATIONS 3.55
84	Building: General Stores Location Reference: <a href="#">L55</a> Task: Access to the roof

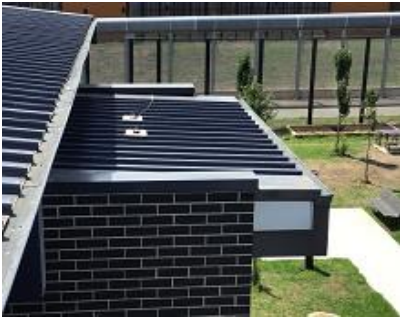
Ladder bracket not installed	Trips, Slips and Falls	Awareness induction	High	Ladder brackets to be installed	Low	Client advised	Outstanding	OH&S REGULATIONS 3.55

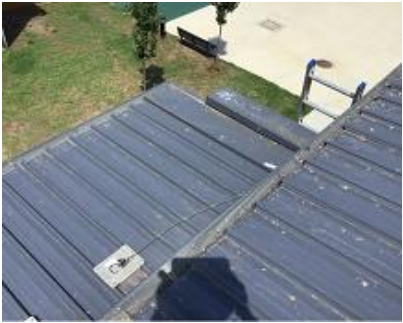
Ladder bracket not installed	Trips, Slips and Falls	Awareness induction	High	Ladder brackets to be installed	Low	Client advised	Outstanding	OH&S REGULATIONS 3.55
86	Building: General Stores Location Reference: <a href="#">L56</a> Task: Access to the roof

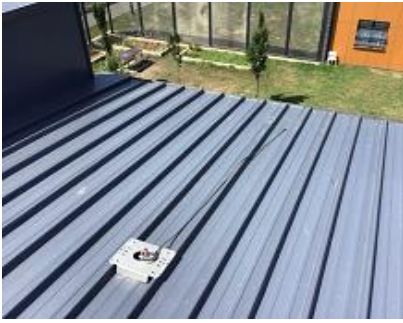
Roof access point is too high to use portable ladder	Trips, Slips and Falls	Awareness induction	High	Strop and sign to be removed. Access ladder from lower roof to be installed	Low	Client advised	Outstanding	OH&S REGULATIONS 3.55

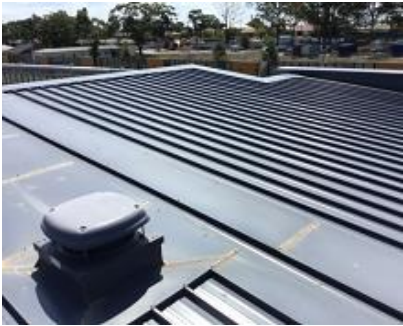
Not enough anchors installed to protect the fall edge	Trips, Slips and Falls	Awareness induction	High	Anchors to be installed	Low	Client advised	Outstanding	OH&S REGULATIONS 3.55
88	Building: General Stores Location Reference: <a href="#">L57</a> Task: Access to the roof

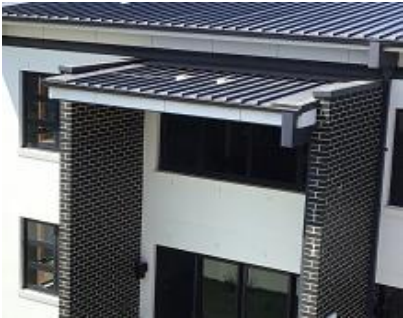
Ladder bracket not installed	Trips, Slips and Falls	Awareness induction	High	Ladder brackets to be installed	Low	Client advised	Outstanding	OH&S REGULATIONS 3.55

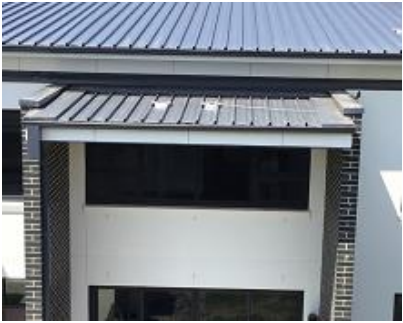
Ladder bracket not installed	Trips, Slips and Falls	Awareness induction	High	Ladder brackets to be installed	Low	Client advised	Outstanding	OH&S REGULATIONS 3.55
90	Building: General Stores Location Reference: <a href="#">L58</a> Task: Access to the roof

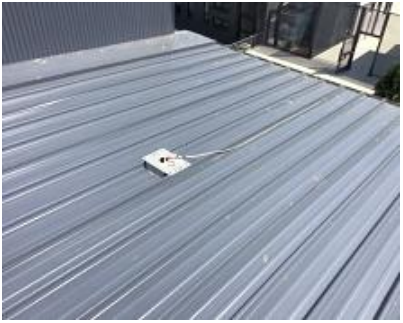
Roof access point is too high to use portable ladder	Trips, Slips and Falls	Awareness induction	High	Strop and sign to be removed. Access ladder from lower roof to be installed	Low	Client advised	Outstanding	OH&S REGULATIONS 3.55

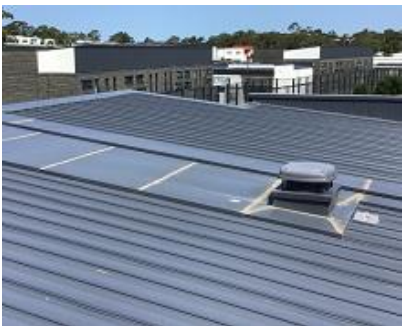
Not enough anchors installed to protect the fall edge	Trips, Slips and Falls	Awareness induction	High	Anchors to be installed	Low	Client advised	Outstanding	OH&S REGULATIONS 3.55
92	Building: General Stores Location Reference: <a href="#">L61</a> Task: Access to the roof

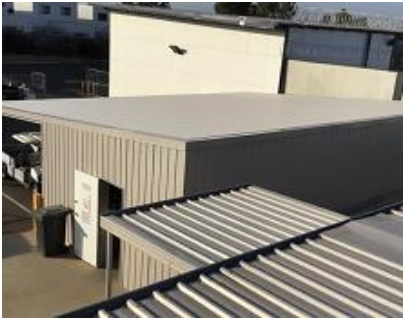
No height safety system installed	Trips, Slips and Falls	Awareness induction	High	Ladder bracket, sign, stop and anchors to be installed	Low	Client advised	Outstanding	OH&S REGULATIONS 3.55

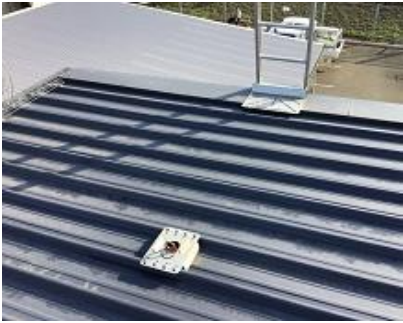
Anchor stop is missing	Trips, Slips and Falls	Awareness induction	High	Anchor stop to be installed	Low	Client advised	Outstanding	OH&S REGULATIONS 3.55
94	Building: General Stores Location Reference: <a href="#">L61</a> Task: Access to the roof

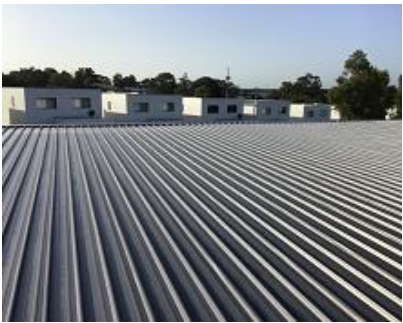
Not enough anchors installed to protect the fall edge	Trips, Slips and Falls	Awareness induction	High	Anchors to be installed	Low	Client advised	Outstanding	OH&S REGULATIONS 3.55

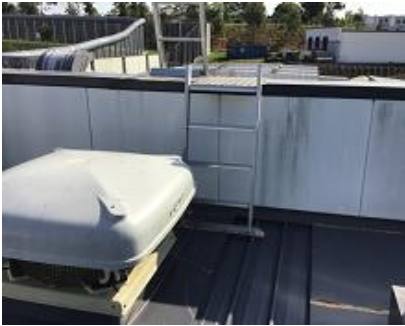
Non-compliant ladder is present	Trips, Slips and Falls	Awareness induction	Med	Existing ladder to be replaced with ladder bracket and access ladder	Low	Client advised	Outstanding	OH&S REGULATIONS 3.7  AS1657-2018 7.4
96	Building: General Stores Location Reference: <a href="#">L63</a> Task: Access to the roof

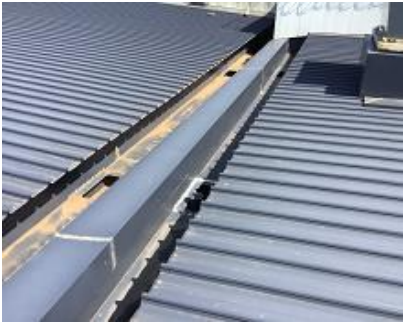
Variation in height between roofs are greater than required maximum	Trips, Slips and Falls	Awareness induction	Med	Platform and Access ladders to be installed	Low	Client advised	Outstanding	OH&S REGULATIONS 3.7  AS1657-2018 3.1.4

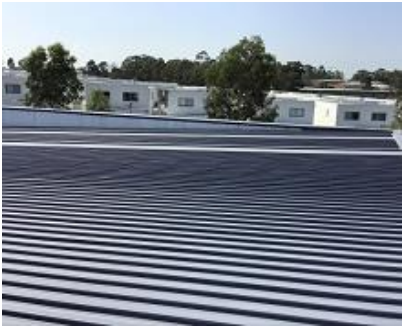
Not enough anchors installed to protect the fall edge	Trips, Slips and Falls	Awareness induction	High	Anchors to be installed	Low	Client advised	Outstanding	OH&S REGULATIONS 3.55
98	Building: General Stores Location Reference: <a href="#">L65</a> Task: Access to the roof

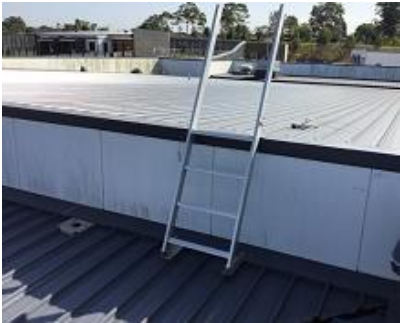
Ladder with un-even rungs and non-complaint	Trips, Slips and Falls	Awareness induction	Med	Existing ladders to be replaced	Low	Client advised	Outstanding	OH&S REGULATIONS 3.7 AS1657-2018 7.4

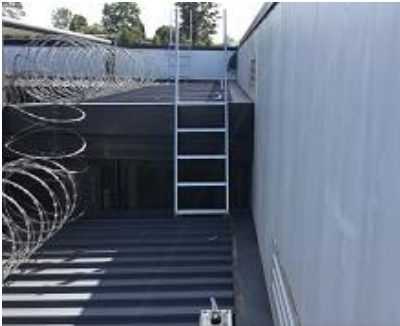
Ladder with un-even rungs and non-complaint	Trips, Slips and Falls	Awareness induction	Med	Existing ladders to be replaced	Low	Client advised	Outstanding	OH&S REGULATIONS 3.7  AS1657-2018 7.4
100	Building: General Stores Location Reference: <a href="#">L67</a> Task: Access to the roof

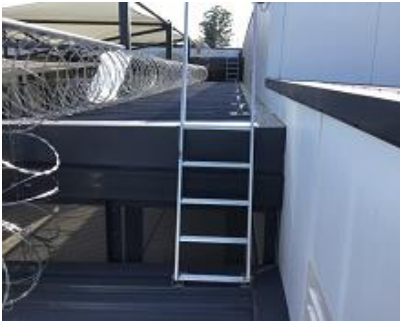
Ladder with un-even rungs and non-complaint	Trips, Slips and Falls	Awareness induction	Med	Existing ladders to be replaced	Low	Client advised	Outstanding	OH&S REGULATIONS 3.7  AS1657-2018 7.4

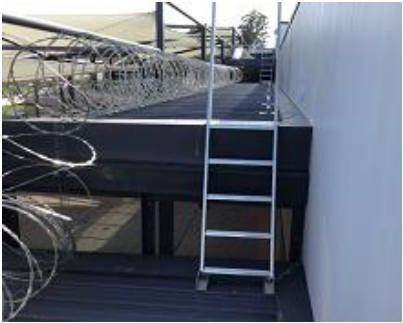
No	Photo of Hazard	Details of Hazard	Details of Risk	Existing/ Immediate Control Measure	Current Risk Level	Proposed Permanent Solution	Residual Risk Assessment	Details of Action Taken	Status	Reference
101	Building: General Stores Location Reference: <a href="#">L68</a> Task: Access to the roof

Ladder with un-even rungs and non-complaint	Trips, Slips and Falls	Awareness induction	Med	Existing ladders to be replaced	Low	Client advised	Outstanding	OH&S REGULATIONS 3.7  AS1657-2018 7.4
102	Building: General Stores Location Reference: <a href="#">L69</a> Task: Access to the roof

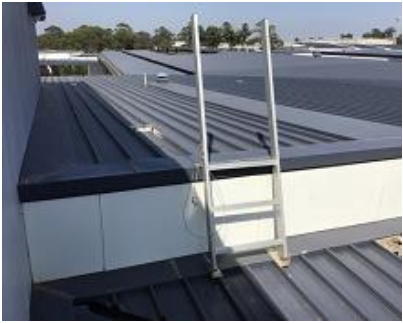
Ladder with un-even rungs and non-complaint	Trips, Slips and Falls	Awareness induction	Med	Existing ladders to be replaced	Low	Client advised	Outstanding	OH&S REGULATIONS 3.7  AS1657-2018 7.4

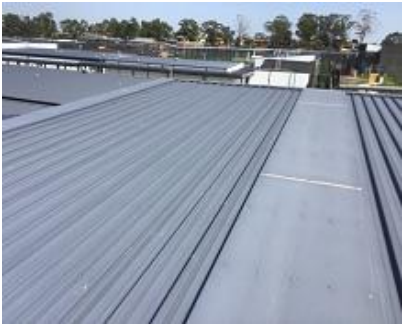
No	Photo of Hazard	Details of Hazard	Details of Risk	Existing/ Immediate Control Measure	Current Risk Level	Proposed Permanent Solution	Residual Risk Assessment	Details of Action Taken	Status	Reference
103	Building: General Stores Location Reference: <a href="#">L64</a> Task: Access to the roof

Not enough anchors installed to protect the fall edge	Trips, Slips and Falls	Awareness induction	High	Anchors to be installed	Low	Client advised	Outstanding	OH&S REGULATIONS 3.55
104	Building: General Stores Location Reference: <a href="#">L70</a> Task: Access to the roof

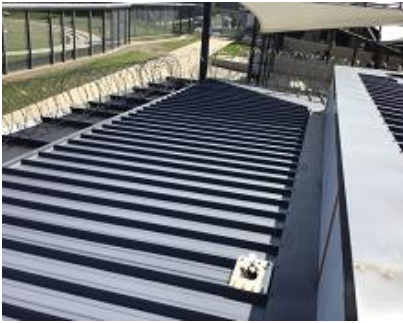
Not enough anchors installed to protect the fall edge	Trips, Slips and Falls	Awareness induction	High	Anchors to be installed	Low	Client advised	Outstanding	OH&S REGULATIONS 3.55

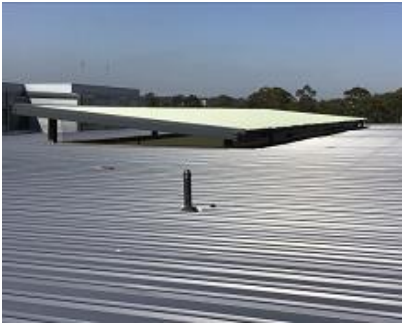
No	Photo of Hazard	Details of Hazard	Details of Risk	Existing/ Immediate Control Measure	Current Risk Level	Proposed Permanent Solution	Residual Risk Assessment	Details of Action Taken	Status	Reference
105	Building: General Stores Location Reference: <a href="#">L71</a> Task: Access to the roof

Brittle and fragile roof section is present	Trips, Slips and Falls	Restrict Access	High	"Brittle and Fragile Roof" signs to be installed	Low	Client advised	Outstanding	OH&S REGULATIONS 3.57
106	Building: General Stores Location Reference: <a href="#">L71</a> Task: Access to the roof

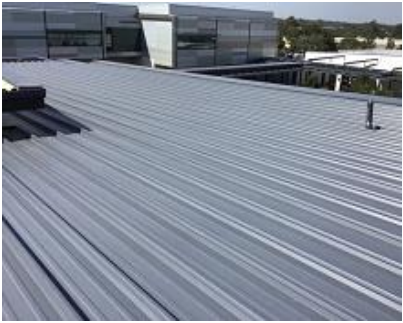
Not enough anchors installed to protect the fall edge	Trips, Slips and Falls	Awareness induction	High	Anchors to be installed	Low	Client advised	Outstanding	OH&S REGULATIONS 3.55

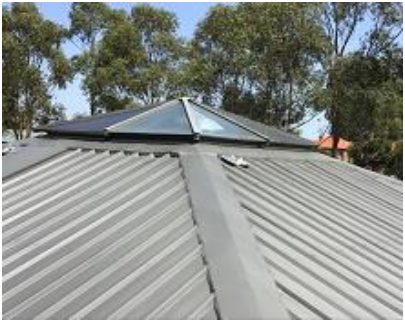
Brittle and fragile roof section is present	Trips, Slips and Falls	Restrict Access	High	"Brittle and Fragile Roof" signs to be installed	Low	Client advised	Outstanding	OH&S REGULATIONS 3.57

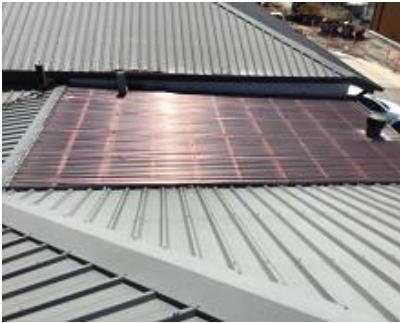
No	Photo of Hazard	Details of Hazard	Details of Risk	Existing/ Immediate Control Measure	Current Risk Level	Proposed Permanent Solution	Residual Risk Assessment	Details of Action Taken	Status	Reference
109	Building: General Stores Location Reference: <a href="#">L73</a> Task: Access to the roof

Brittle and fragile roof section is present	Trips, Slips and Falls	Restrict Access	High	"Brittle and Fragile Roof" signs to be installed	Low	Client advised	Outstanding	OH&S REGULATIONS 3.57
110	Building: General Stores Location Reference: <a href="#">L73</a> Task: Access to the roof

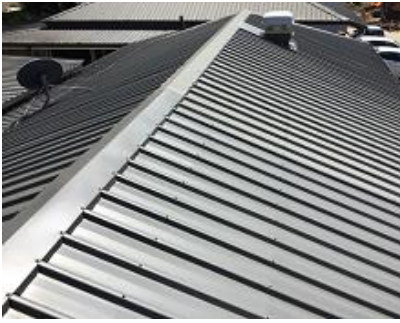
Not enough anchors installed to protect the fall edge	Trips, Slips and Falls	Awareness induction	High	Anchors to be installed	Low	Client advised	Outstanding	OH&S REGULATIONS 3.55

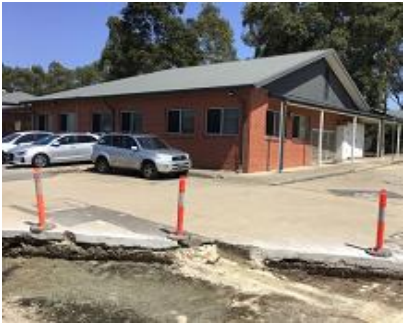
No	Photo of Hazard	Details of Hazard	Details of Risk	Existing/ Immediate Control Measure	Current Risk Level	Proposed Permanent Solution	Residual Risk Assessment	Details of Action Taken	Status	Reference
111	Building: General Stores Location Reference: <a href="#">L74</a> Task: Access to the roof

No height safety system installed	Trips, Slips and Falls	Awareness induction	High	Ladder bracket, sign, strop and anchors to be installed	Low	Client advised	Outstanding	OH&S REGULATIONS 3.55
112	Building: General Stores Location Reference: <a href="#">L75</a> Task: Access to the roof

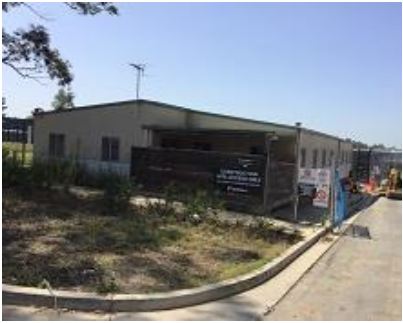
Brittle and fragile roof section is present	Trips, Slips and Falls	Restrict Access	High	"Brittle and Fragile Roof" signs to be installed	Low	Client advised	Outstanding	OH&S REGULATIONS 3.57

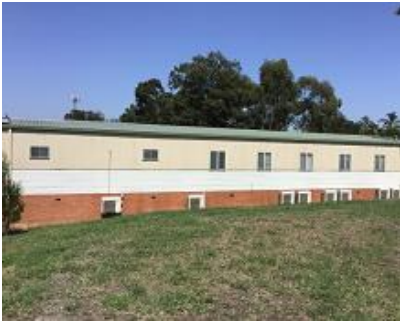
No	Photo of Hazard	Details of Hazard	Details of Risk	Existing/ Immediate Control Measure	Current Risk Level	Proposed Permanent Solution	Residual Risk Assessment	Details of Action Taken	Status	Reference
113	Building: General Stores Location Reference: <a href="#">L75</a> Task: Access to the roof

No height safety system installed	Trips, Slips and Falls	Awareness induction	High	Ladder bracket, sign, strop and anchors to be installed	Low	Client advised	Outstanding	OH&S REGULATIONS 3.55
114	Building: General Stores Location Reference: <a href="#">L76</a> Task: Access to the roof

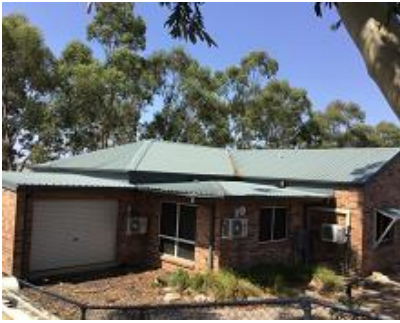
No height safety system installed	Trips, Slips and Falls	Awareness induction	High	Ladder bracket, sign, strop and anchors to be installed	Low	Client advised	Outstanding	OH&S REGULATIONS 3.55

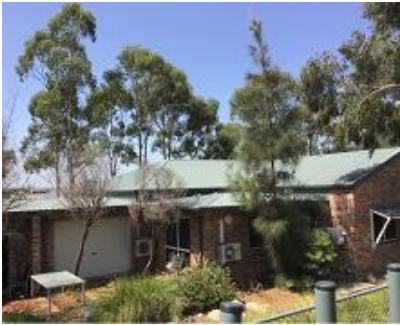
No	Photo of Hazard	Details of Hazard	Details of Risk	Existing/ Immediate Control Measure	Current Risk Level	Proposed Permanent Solution	Residual Risk Assessment	Details of Action Taken	Status	Reference
115	Building: General Stores Location Reference: <a href="#">L77</a> Task: Access to the roof

No height safety system installed	Trips, Slips and Falls	Awareness induction	High	Ladder bracket, sign, strop and anchors to be installed	Low	Client advised	Outstanding	OH&S REGULATIONS 3.55
116	Building: General Stores Location Reference: <a href="#">L78</a> Task: Access to the roof

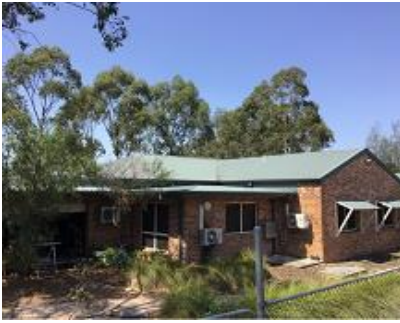
No height safety system installed	Trips, Slips and Falls	Awareness induction	High	Ladder bracket, sign, strop and anchors to be installed	Low	Client advised	Outstanding	OH&S REGULATIONS 3.55

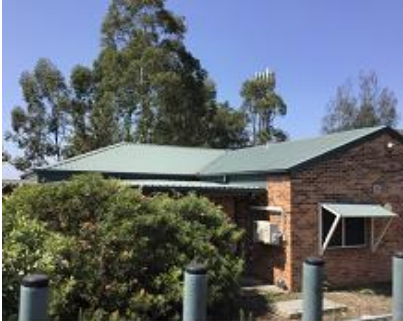
No	Photo of Hazard	Details of Hazard	Details of Risk	Existing/ Immediate Control Measure	Curre nt Risk Level	Proposed Permanent Solution	Resid ual Risk Asse ssme nt	Details of Action Taken	Status	Reference
117	Building: General Stores Location Reference: <a href="#">L79</a> Task: Access to the roof

No height safety system installed	Trips, Slips and Falls	Awareness induction	High	Ladder bracket, sign, strop and anchors to be installed	Low	Client advised	Outstanding	OH&S REGULATIONS 3.55
