# Roof Safety Report

Warwick Grove,

Prepared By: Safemaster Safety Products  
Date: 24-10-2020

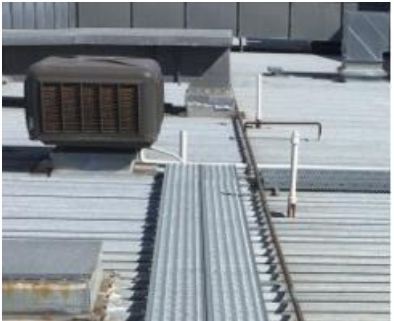
Pipes installed over walkway and gap between the walkway sections	Trips, Slips and Falls	Awarness induction	Med	New single step over to be installed with high visibility safety yellow nosings	Low	Client advised	Out-standing	AS 1657-2018 3.3.4 OH&S REGULATIONS 3.6

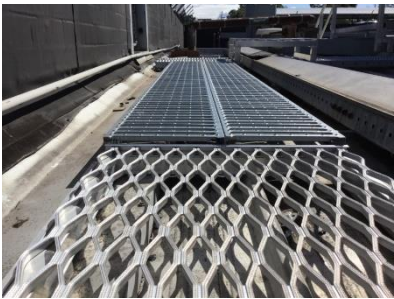
Variation in height between adjacent walkway levels are greater than required maximum	Trips, Slips and Falls	Awarness induction	Med	High visibility safety yellow nosing to be installed	Low	Client advised	Out-standing	AS 1657-2018 3.3.4 OH&S REGULATIONS 3.6

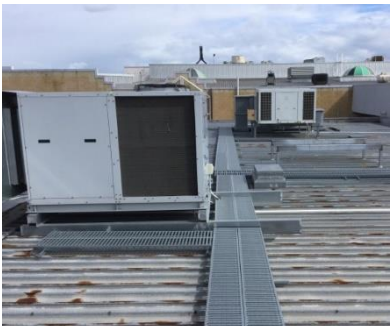
Variation in height between walkway and adjacent levels are greater than required maximum	Trips, Slips and Falls	Awareness induction	Med	High visibility safety yellow nosing's to be installed	Low	Client advised	Outstanding	AS 16572018 3.3.4  OH&S REGULATIONS 3.6

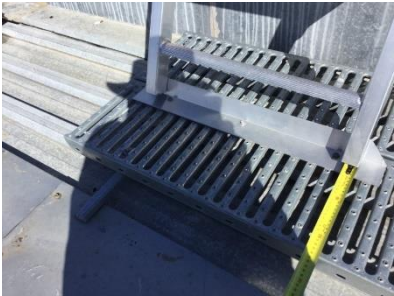
Ladder landing is less than required minimum	Trips, Slips and Falls	Awareness induction	Med	New landing platform to be installed	Low	Client advised	Outstanding	AS 1657-2018 7.3.6

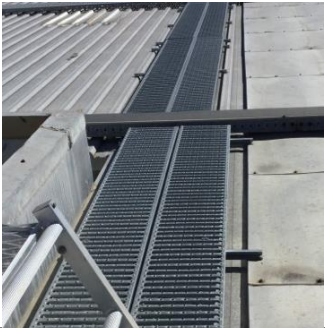
Variation in height between walkway and adjacent levels are greater than required maximum	Trips, Slips and Falls	Awareness induction	Med	High visibility safety yellow tape to be installed	Low	Client advised	Outstanding	AS 16572018 3.3.4  OH&S REGULATIONS 3.6
44	Building: General Stores Location Reference: <a href="#">L44</a> Task: Restrict access to the roof

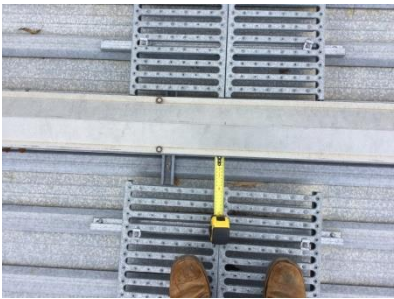
Variation in height between walkway and adjacent levels are greater than required maximum	Trips, Slips and Falls	Awareness induction	Med	High visibility safety yellow tape to be installed	Low	Client advised	Outstanding	AS 16572018 3.3.4  OH&S REGULATIONS 3.6

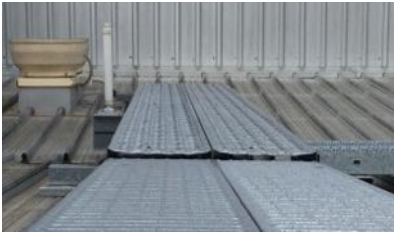
Variation in height between walkway and adjacent levels are greater than required maximum	Trips, Slips and Falls	Awareness induction	Med	High visibility safety yellow nosing to be installed	Low	Client advised	Outstanding	AS 16572018 3.3.4  OH&S REGULATIONS 3.6
54	Building: General Stores Location Reference: <a href="#">L60</a> Task: Restrict access to the roof

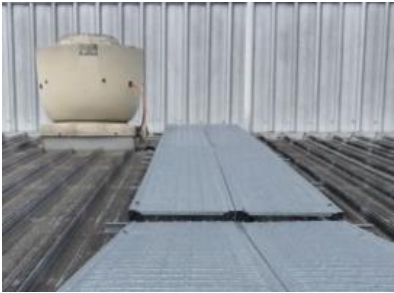
Variation in height between walkway and adjacent levels are greater than required maximum	Trips, Slips and Falls	Awareness induction	Med	High visibility safety yellow nosing to be installed	Low	Client advised	Outstanding	AS 16572018 3.3.4  OH&S REGULATIONS 3.6

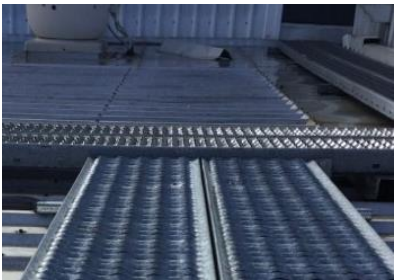
Variation in height between walkway and adjacent levels are greater than required maximum	Trips, Slips and Falls	Awareness induction	Med	High visibility safety yellow nosing to be installed	Low	Client advised	Outstanding	AS 16572018 3.3.4  OH&S REGULATIONS 3.6

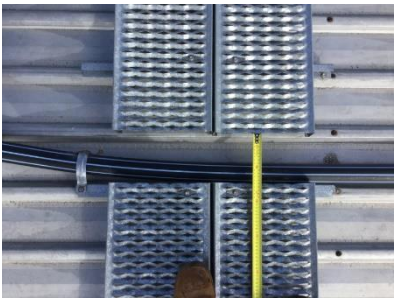
Variation in height between walkway and adjacent levels are greater than required maximum	Trips, Slips and Falls	Awareness induction	Med	High visibility safety yellow nosing to be installed	Low	Client advised	Outstanding	AS 16572018 3.3.4  OH&S REGULATIONS 3.6

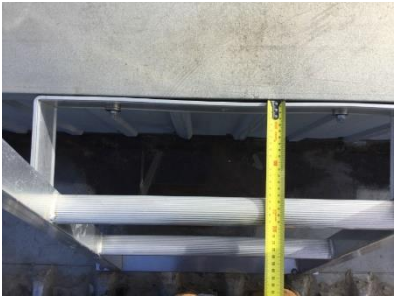
Clearance between the back edge of rung and permanent structure is less than required minimum	Trips, Slips and Falls	Awareness induction	High	Existing mini ladder to removed And New steps to be installed	Low	Client advised	Outstanding	AS 16572018 7.4.5

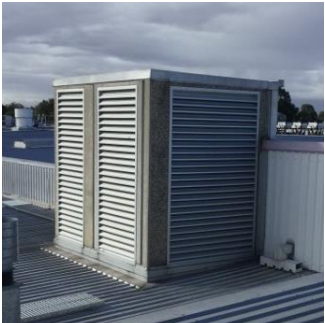
No height safety system installed (no serviceable items)	Trips, Slips and Falls	Awareness induction	Med	"EWP ACCESS ONLY" sign to be installed	Low	Client advised	Outstanding	OH&S REGULATIONS 3.11 & 3.55

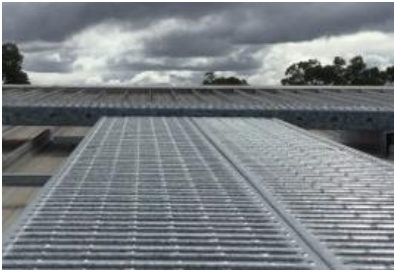
Variation in height between walkway and adjacent levels are greater than required maximum	Trips, Slips and Falls	Awareness induction	High	High visibility safety yellow nosing to be installed	Low	Client advised	Outstanding	AS 16572018 3.3.4  OH&S REGULATIONS 3.6
72	Building: General Stores Location Reference: <a href="#">L98</a> Task: Access to the roof

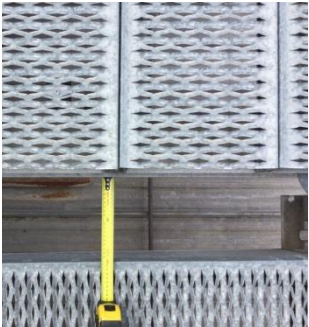
Walkway missing (gap between the walkway panels)	Trips, Slips and Falls	Awareness induction	Med	Walkway to be installed to close the gap between walkway panels	Low	Client advised	Outsta nding	OH&S REGULATIONS 3.7
74	Building: General Stores Location Reference: <a href="#">L98</a> Task: Restrict access to the roof

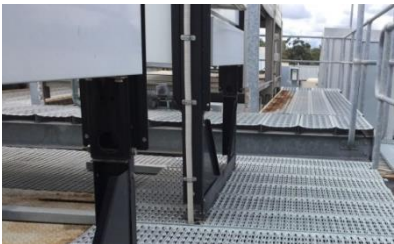
Variation in height between walkway and adjacent levels are greater than required maximum	Trips, Slips and Falls	Awareness induction	Med	High visibility safety yellow nosing to be installed	Low	Client advised	Outsta nding	AS 16572018 3.3.4  OH&S REGULATIONS 3.6

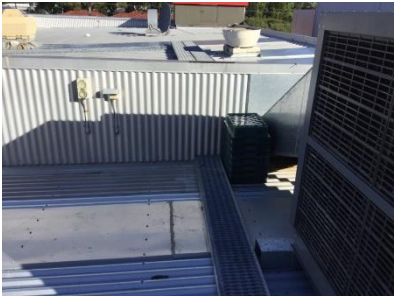
No safe access between levels	Trips, Slips and Falls	Awareness induction	Med	Permanent ladder to be installed	Low	Client advised	Outstanding	AS 1657-2018 3.1.4  OH&S REGULATIONS 3.7

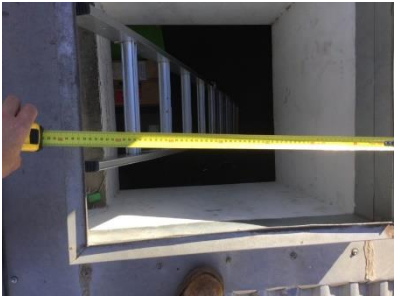
Clearance between the back edge of ladder and the hatch is less than required minimum	Trips, Slips and Falls	Awareness induction	Med	Existing hatch to be removed and New 1200x800mm hatch to be installed with ladder bracket or Install external access ladder bracket/anchors	Low	Client advised	Outstanding	AS 16572018 7.4.5

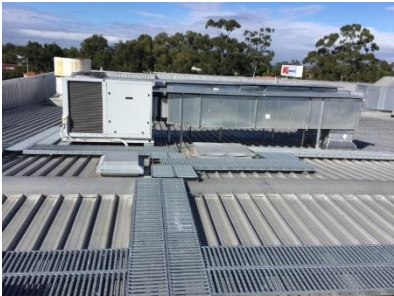
Roof walkway not installed for the safe access and egress to the new A/C unit	Trips, Slips and Falls	N/A	Low	Supply walkway sections to join walkways	Low	Client advised	Outstanding	-

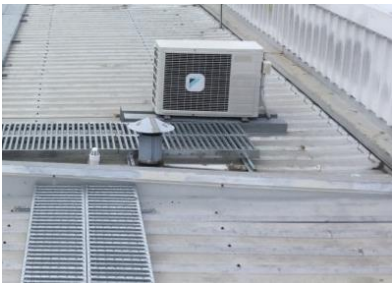
Roof walkway not installed for the safe access and egress to the new A/C unit	Trips, Slips and Falls	N/A	Low	Supply walkway and step up as required	Low	Client advised	Outstanding	-

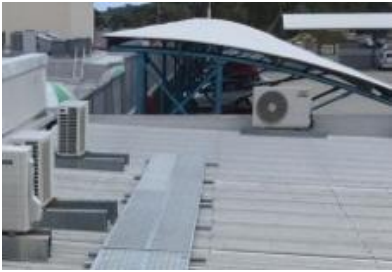
Roof walkway not installed for the safe access and egress to the new A/C unit	Trips, Slips and Falls	N/A	Low	Supply walkway to A/C unit	Low	Client advised	Outstanding	-
104	Building: General Stores Location Reference: <a href="#">L94</a> Task: Access to the roof

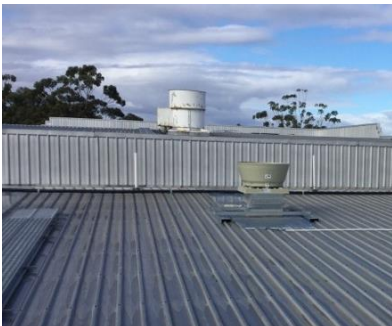
Roof walkway not installed for the safe access and egress to the new A/C unit	Trips, Slips and Falls	N/A	Low	Supply walkway to A/C unit	Low	Client advised	Outstanding	-

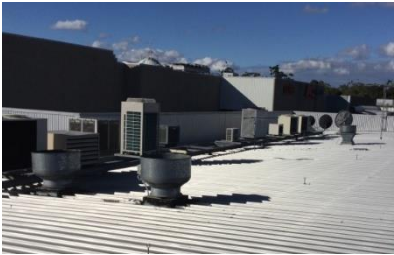
Roof walkway not installed for the safe access and egress to the new A/C unit	Trips, Slips and Falls	N/A	Low	Supply walkway to A/C units	Low	Client advised	Outstanding	-

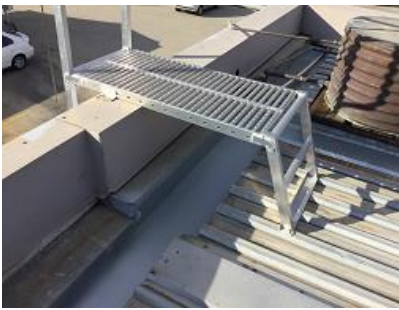
Variation in height between platform and roof is greater than required maximum	Trips, Slips and Falls	Awareness induction	Med	Handrails to be installed	Low	Client advised	Outstanding	OH&S REGULATIONS 3.7  AS 1657-2018 4.4

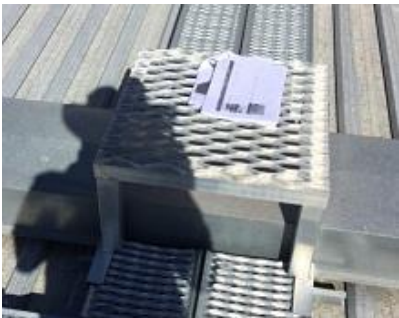
Step height is greater than required maximum	Trips, Slips and Falls	Awareness induction	Med	Existing step to be modified to comply	Low	Client advised	Outstanding	OH&S REGULATIONS 3.7  AS 1657-2018 3.1.4

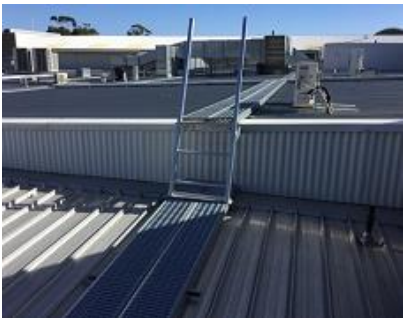
Bottom rung height is less than required minimum	Trips, Slips and Falls	Awareness induction	Med	Landing platform to be installed	Low	Client advised	Outstanding	OH&S REGULATIONS 3.7  AS 1657-2018 7.4.3.4

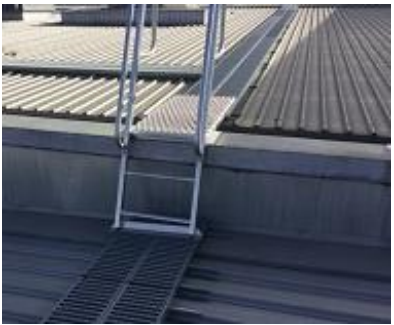
Bottom rung height is less than required minimum and handrails projecting towards the user	Trips, Slips and Falls	Awareness induction	Med	Existing handrails to be removed. Landing platforms and handrails to be installed	Low	Client advised	Outstanding	OH&S REGULATIONS 3.7  AS 1657-2018 7.4.3.4 & 7.4.8.5

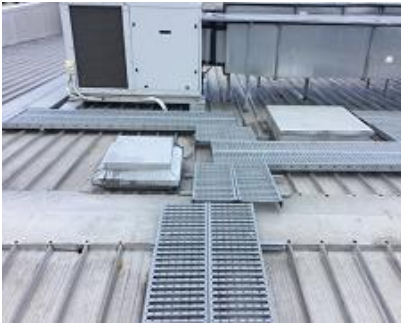
No safe access to the A/c units	Trips, Slips and Falls	N/A	Low	Supply walkway to the A/c units	Low	Client advised	Outstanding	-
131	Building: General Stores Location Reference: <a href="#">L64</a> Task: Access to the roof

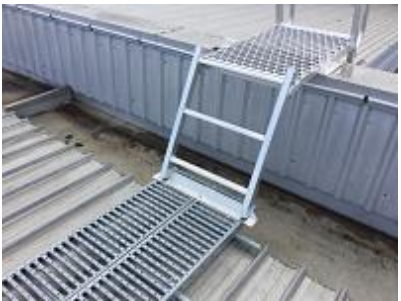
Sharp edges on ladders and Bottom rung height is less than required minimum	Trips, Slips and Falls	Awareness induction	Med	Tek screws to be replaced with rivets and landing platform to be installed	Low	Client advised	Outstanding	OH&S REGULATIONS 3.7  AS 1657-2018 5.6 & 7.4.3.4

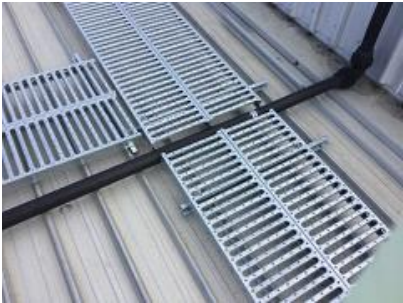
Gap between walkway panels are greater than required maximum	Trips, Slips and Falls	Awareness induction	Med	Checker plate to be installed	Low	Client advised	Outstanding	OH&S REGULATIONS 3.7  AS 1657-2018 3.2.3.4

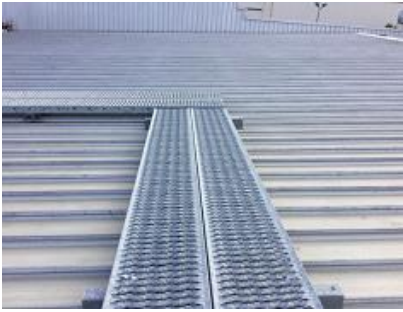
Variation in height between walkway panels are greater than required maximum	Trips, Slips and Falls	Awareness induction	Med	High visibility safety yellow nosing to be installed	Low	Client advised	Outstanding	OH&S REGULATIONS 3.7  AS 1657-2018 3.3.4
135	Building: General Stores Location Reference: <a href="#">L97</a> Task: Access to the A/c unit

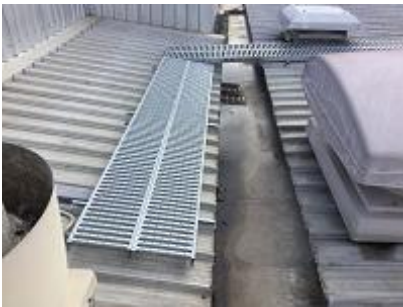
Angle across the walkway path is greater than required maximum	Trips, Slips and Falls	Awareness induction	Med	Walkway to be re-installed with levelling brackets	Low	Client advised	Outstanding	OH&S REGULATIONS 3.7  AS 1657-2018 5.1.1

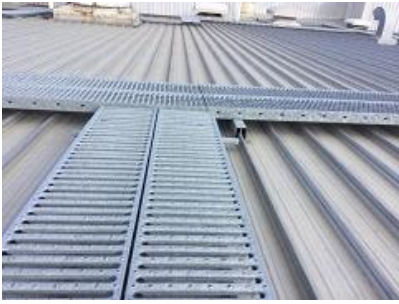
Variation in height between walkway panels are greater than required maximum	Trips, Slips and Falls	Awareness induction	Med	High visibility safety yellow nosing to be installed	Low	Client advised	Outstanding	OH&S REGULATIONS 3.7  AS 1657-2018 3.3.4
137	Building: General Stores Location Reference: <a href="#">L98</a> Task: Access to the plant deck

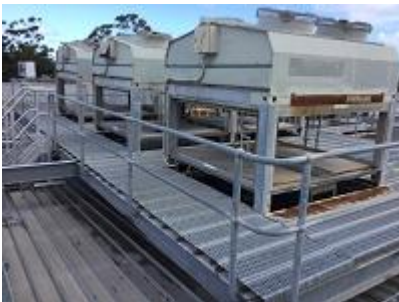
Variation in height between plant deck and unit is greater than required maximum	Trips, Slips and Falls	Awareness induction	Med	Mid rail around units to be installed	Low	Client advised	Outstanding	OH&S REGULATIONS 3.7  AS 1657-2018 4.4

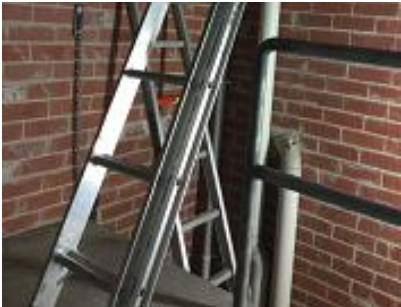
Gap between handrail and ladder is greater than required maximum	Trips, Slips and Falls	Awareness induction	Med	Handrail to be extended	Low	Client advised	Outstanding	OH&S REGULATIONS 3.7  AS 1657-2018 4.4

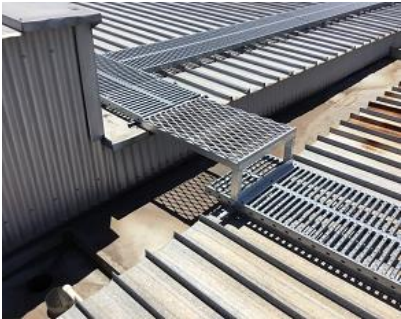
Variation in height between walkway and adjacent surface is greater than required maximum	Trips, Slips and Falls	Awareness induction	Med	Handrails to be installed	Low	Client advised	Outstanding	OH&S REGULATIONS 3.7  AS 1657-2018 4.4

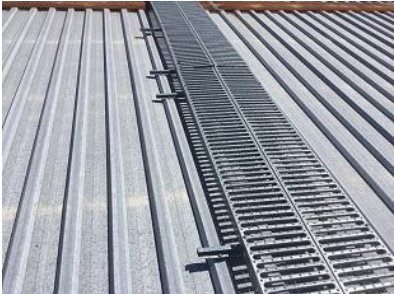
Walkway sections became loose	Trips, Slips and Falls	Awareness induction	Med	Walkway sections to be secured	Low	Client advised	Outstanding	OH&S REGULATIONS 3.7
144	Building: General Stores Location Reference: <a href="#">L31</a> Task: Access to the roof

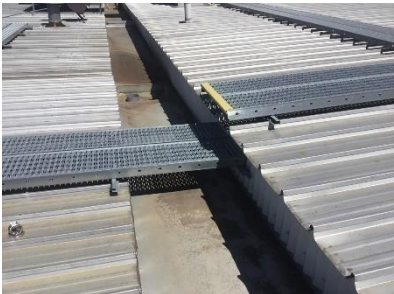
Variation in height between walkway and box gutter is greater than required maximum	Trips, Slips and Falls	Awareness induction	Med	Handrail to both sides of walkway including "D" ends and single step to be installed	Low	Client advised	Outstanding	OH&S REGULATIONS 3.7 AS 1657-2018 4.4 & 3.1.4

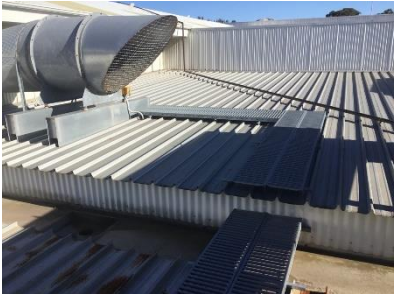
Variation in height between walkway and box gutter is greater than required maximum	Trips, Slips and Falls	Awareness induction	Med	Handrail to both sides of walkway including "D" ends and single step to be installed	Low	Client advised	Outstanding	OH&S REGULATIONS 3.7  AS 1657-2018 4.4 & 3.1.4
146	Building: General Stores Location Reference: <a href="#">L38</a> Task: Access to the roof

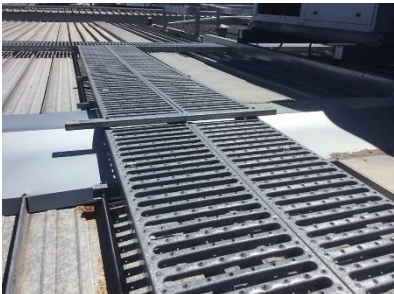
Bracing installed over the walkway path	Trips, Slips and Falls	Awareness induction	Med	High visibility safety yellow nosing to be installed	Low	Client advised	Outstanding	OH&S REGULATIONS 3.7  AS 1657-2018 3.3.4

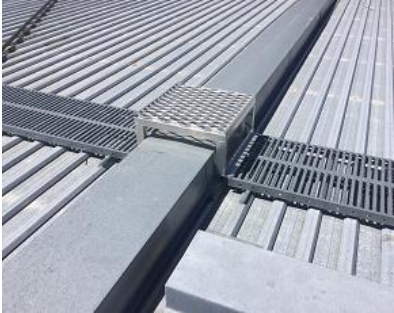
Step height is greater than required maximum	Trips, Slips and Falls	Awareness induction	High	Step height to modified and re-installed	Low	Client advised	Outstanding	OH&S REGULATIONS 3.7  AS 1657-2018 3.1.4
148	Building: General Stores Location Reference: <a href="#">L55</a> Task: Access to the roof

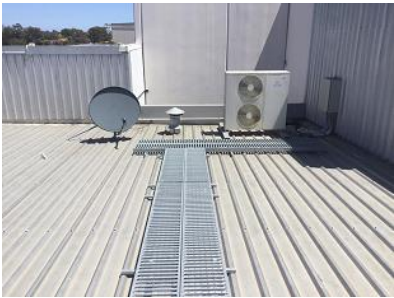
Roof walkway leads to a fall edge (a fall arrest system is in place)	Trips, Slips and Falls	Awareness induction	High	"SAFETY HARNESS TO BE ATTACHED TO ANCHOR POINT" sign to be installed	Low	Client advised	Outstanding	AS 16572018 5.4.1  OH&S REGULATIONS 3.11 & 3.55

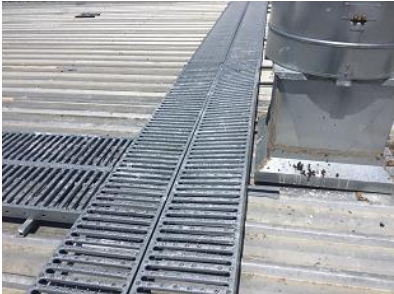
Walkway sections became loose	Trips, Slips and Falls	Awareness induction	Med	Walkway sections to be secured	Low	Client advised	Outstanding	OH&S REGULATIONS 3.7
150	Building: General Stores Location Reference: <a href="#">L58</a> Task: Access to the roof

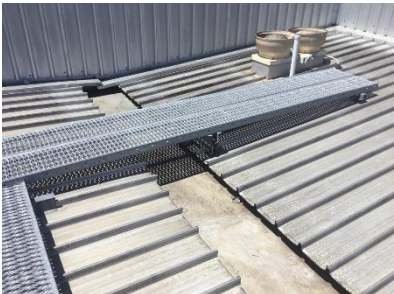
Variation in height between walkway and box gutter is greater than required maximum	Trips, Slips and Falls	Awareness induction	Med	Handrail to both sides of walkway to be installed	Low	Client advised	Outstanding	OH&S REGULATIONS 3.7 AS 1657-2018 4.4

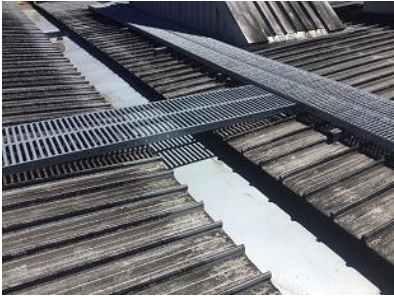
Variation in height between walkway and box gutter is greater than required maximum	Trips, Slips and Falls	Awareness induction	Med	Handrail to both sides of walkway to be installed	Low	Client advised	Outstanding	OH&S REGULATIONS 3.7  AS 1657-2018 4.4
152	Building: General Stores Location Reference: <a href="#">L60</a> Task: Access to the roof

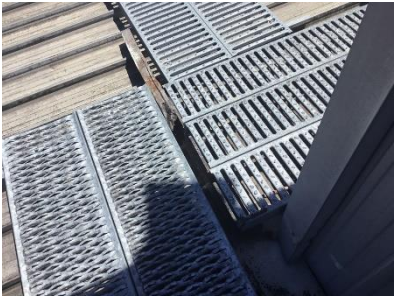
Gap between walkway panels are greater than required maximum	Trips, Slips and Falls	Awareness induction	Med	Gap to be filled	Low	Client advised	Outstanding	OH&S REGULATIONS 3.7  AS 1657-2018 3.3.4

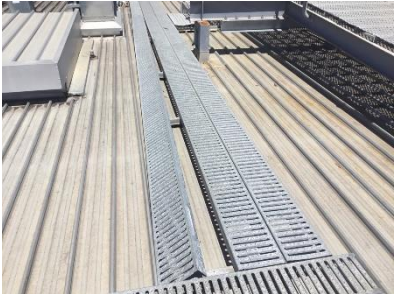
Walkway sections became loose	Trips, Slips and Falls	Awareness induction	Med	Walkway sections to be secured	Low	Client advised	Outstanding	OH&S REGULATIONS 3.7
154	Building: General Stores Location Reference: <a href="#">L62</a> Task: Access to the roof

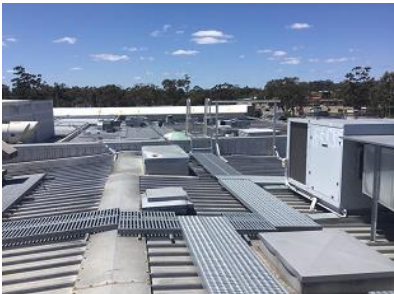
Handrail is damaged	Trips, Slips and Falls	Awareness induction	Med	Handrail to be replaced	Low	Client advised	Outstanding	OH&S REGULATIONS 3.7 AS 1657-2018 4.4

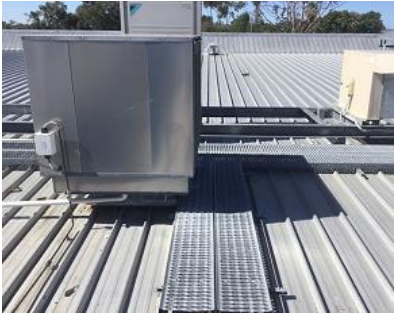
A/c unit protruding over the walkway path	Trips, Slips and Falls	Awareness induction	Med	Additional walkway section to be installed	Low	Client advised	Outstanding	OH&S REGULATIONS 3.7  AS 1657-2018 3.3.4
156	Building: General Stores Location Reference: <a href="#">L123</a> Task: Access to the roof

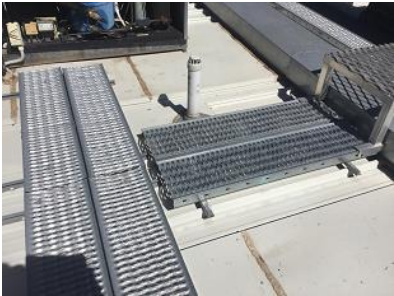
Variation in height between walkway panels are greater than required maximum	Trips, Slips and Falls	Awareness induction	Med	High visibility safety yellow nosing to be installed	Low	Client advised	Outstanding	OH&S REGULATIONS 3.7  AS 1657-2018 3.3.4

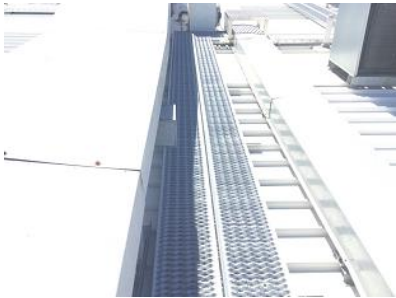
A/c unit protruding over the walkway path	Trips, Slips and Falls	Awareness induction	Med	Additional walkway section to be installed	Low	Client advised	Outstanding	OH&S REGULATIONS 3.7  AS 1657-2018 3.3.4
158	Building: General Stores Location Reference: <a href="#">L124</a> Task: Access to the roof

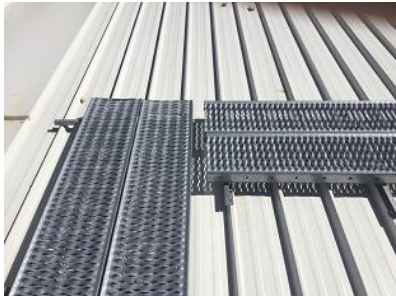
Gap between walkway panels are greater than required maximum	Trips, Slips and Falls	Awareness induction	Med	Gap to be filled	Low	Client advised	Outstanding	OH&S REGULATIONS 3.7  AS 1657-2018 3.3.4

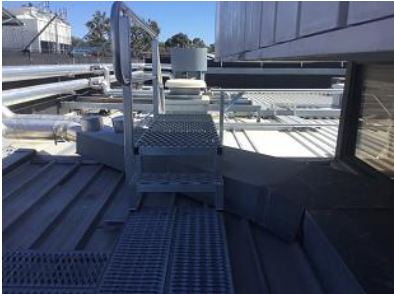
No	Photo of Hazard	Details of Hazard	Details of Risk	Existing/ Immediate Control Measure	Curren t Risk Level	Proposed Permanent Solution	Residu al Risk Assess ment	Details of Action Taken	Status	Reference
159	Building: General Stores Location Reference: <a href="#">L18</a> Task: Access to the roof

Handrail is missing for one side	Trips, Slips and Falls	Awareness induction	Med	Handrail to be installed	Low	Client advised	Outstanding	OH&S REGULATIONS 3.7  AS 1657-2018 4.4
