Roof Safety Report

**Whitsunday Plaza,
QLD 4802**

Prepared By: Safemaster Safety Products
Date: 09 Aug 2017

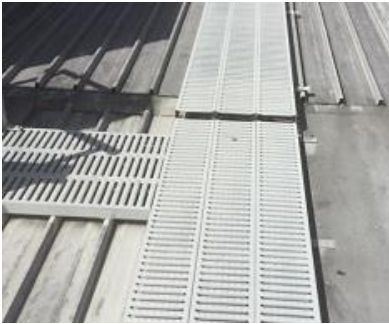
Variation in height between walkway panels are greater than required maximum	Trips, Slips and Falls	Awareness induction	Med	High visibility safety yellow nosing to be installed	Low	Client advised	Outstanding	OH&S REGULATIONS 3.7 AS/NZS 1657-2013 3.3.4

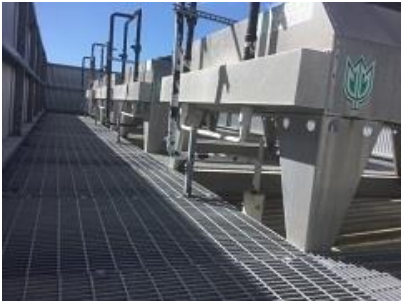
Variation in height between plant deck and unit is greater than required maximum	Trips, Slips and Falls	Awareness induction	Med	Mid rail to be installed	Low	Client advised	Outstanding	OH&S REGULATIONS 3.7 AS/NZS 1657-2013 4.4

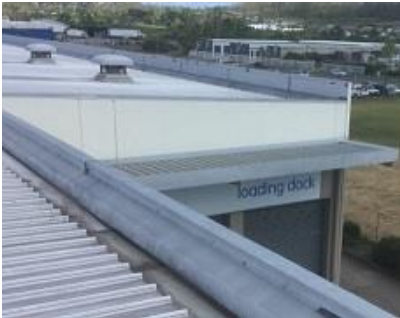
No height safety system installed (No serviceable items)	Trips, Slips and Falls	Restrict Access	High	"EWP Access Only" sign to be installed	Low	Client advised	Outstanding	OH&S REGULATIONS 3.55 & 3.11

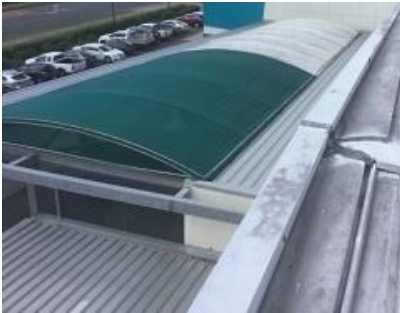
No height safety system installed (No serviceable items)	Trips, Slips and Falls	Restrict Access	High	"EWP Access Only" signs to be installed	Low	Client advised	Outstanding	OH&S REGULATIONS 3.55 & 3.11

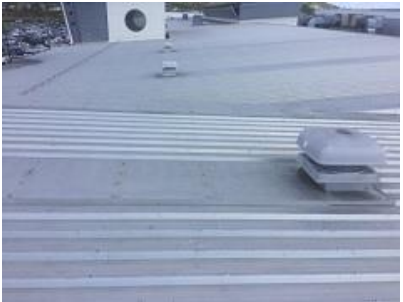
No safe access to the A/c units	Trips, Slips and Falls	N/A	Low	Supply walkway to the A/c unit	Low	Client advised	Outstanding	-

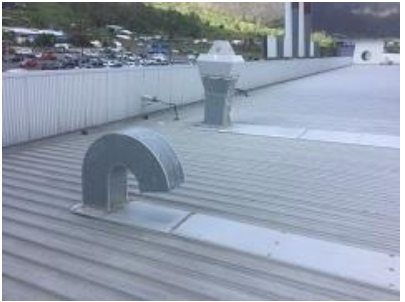
No safe access to the A/c units	Trips, Slips and Falls	N/A	Low	Supply walkway to the A/c units	Low	Client advised	Outstanding	-

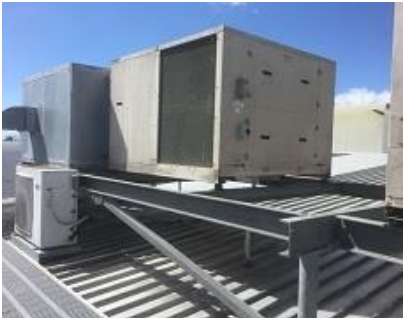
No safe access to the A/c unit	Trips, Slips and Falls	Awareness induction	Med	Access ladder, walkway mesh and handrails to be installed	Low	Client advised	Outstanding	OH&S REGULATIONS 3.7 AS/NZS 1657-2013 3.1.4

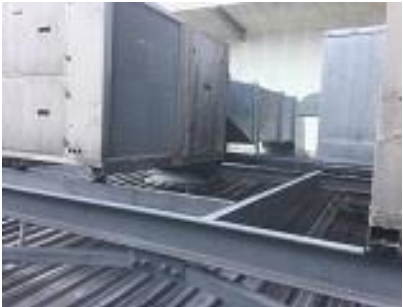
No safe access to the A/c unit	Trips, Slips and Falls	Awareness induction	Med	Access ladder, walkway mesh and handrails to be installed	Low	Client advised	Outstanding	OH&S REGULATIONS 3.7 AS/NZS 1657-2013 3.1.4

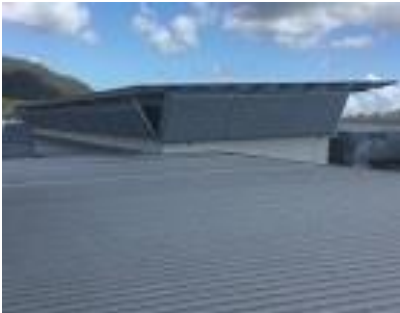
No height safety system installed	Trips, Slips and Falls	Awareness induction	High	Fall arrest anchors, Anchor stop and Ladder access bracket to be installed	Low	Client advised	Outstanding	OH&S REGULATIONS 3.55

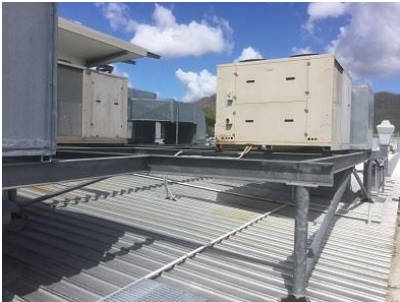
No safe access to the plant deck	Trips, Slips and Falls	Awareness induction	Med	Access ladder, walkway mesh and handrails to be installed	Low	Client advised	Outstanding	OH&S REGULATIONS 3.7 AS/NZS 1657-2013 3.1.4

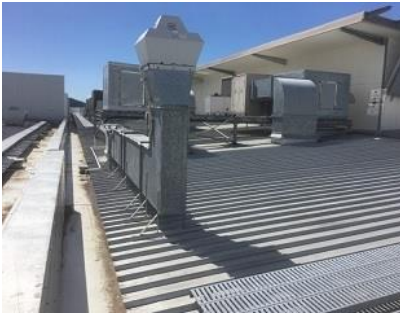
No safe access to the A/c units	Trips, Slips and Falls	N/A	Low	Supply walkway to the A/c units	Low	Client advised	Outstanding	-

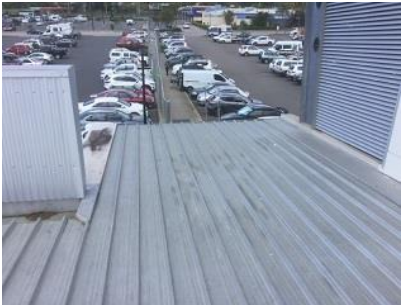
No height safety system installed	Trips, Slips and Falls	Awareness induction	High	Fall arrest anchor to be installed	Low	Client advised	Outstanding	OH&S REGULATIONS 3.55

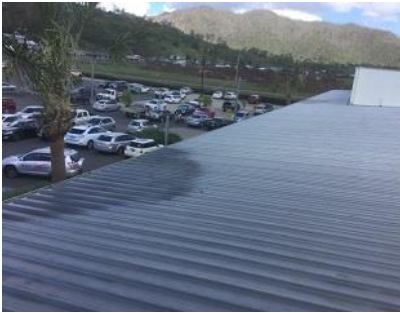
No height safety system installed	Trips, Slips and Falls	Awareness induction	High	Fall arrest anchor to be installed	Low	Client advised	Outstanding	OH&S REGULATIONS 3.55

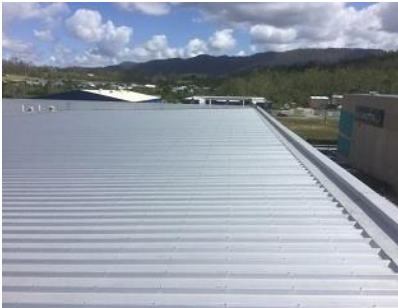
No height safety system installed	Trips, Slips and Falls	Awareness induction	High	Fall arrest anchors to be installed	Low	Client advised	Outstanding	OH&S REGULATIONS 3.55

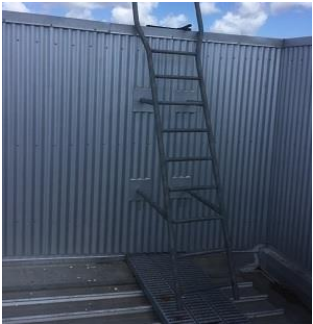
Top rung not levelled with landing, bottom rung height is less than required minimum and no slip resistance on ladder rungs	Trips, Slips and Falls	Awareness induction	Med	Existing ladder to be removed and new ladder to be installed	Low	Client advised	Outstanding	OH&S REGULATIONS 3.7 AS/NZS 1657-2013 7.4.3.3, 7.4.3.4 & 7.4.3.1

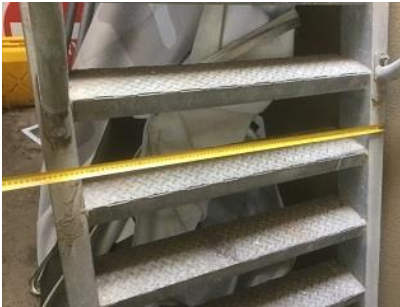
Ladder width is greater than required maximum	Trips, Slips and Falls	Awareness induction	Med	Existing ladder to be removed and New ladder to be installed	Low	Client advised	Outstanding	OH&S REGULATIONS 3.7 AS/NZS 1657-2013 7.3.1

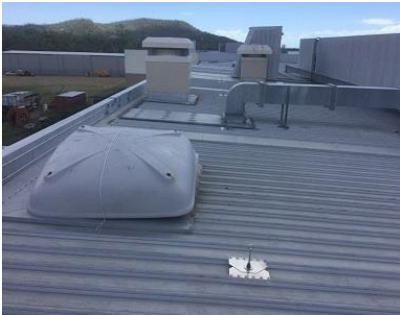
No safe access to the A/c units	Trips, Slips and Falls	N/A	Low	Supply walkway to the A/c units	Low	Client advised	Outstanding	-

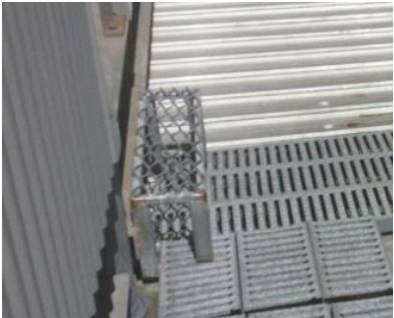
Non-complaint step	Trips, Slips and Falls	Awareness induction	Med	Existing step to be removed and new step to be installed	Low	Client advised	Outstanding	OH&S REGULATIONS 3.7 AS/NZS 1657-2013 3.1.4

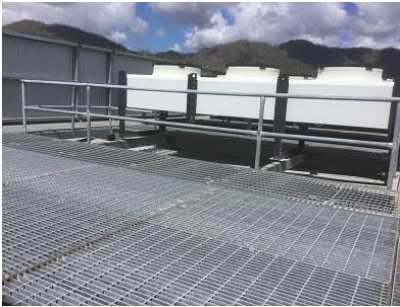
Handrail height is less than required minimum	Trips, Slips and Falls	Awareness induction	Med	Existing handrail to be removed and New handrails to be installed	Low	Client advised	Outstanding	OH&S REGULATIONS 3.7 AS/NZS 1657-2013 4.4

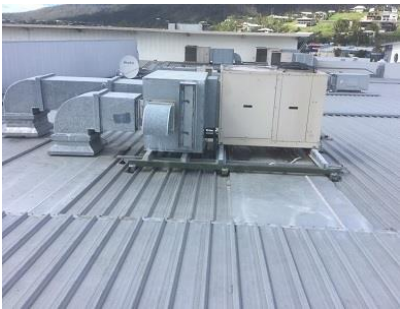
No safe access to the A/c units	Trips, Slips and Falls	N/A	Low	Supply walkway to the A/c units	Low	Client advised	Outstanding	-

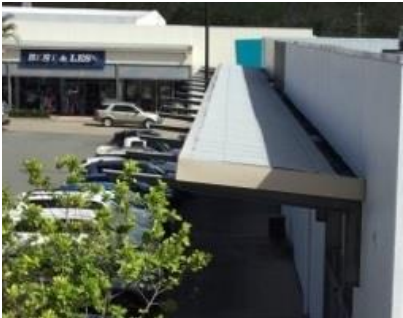
No height safety system installed	Trips, Slips and Falls	Restrict Access	High	"EWP Access Only" sign to be installed	Low	Client advised	Outstanding	OH&S REGULATIONS 3.55 & 3.11

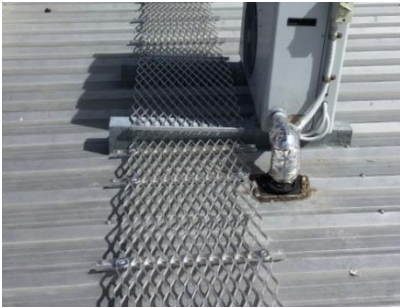
Variation in height between walkway panels are greater than required maximum	Trips, Slips and Falls	Awareness induction	Med	High visibility safety yellow nosing to be installed	Low	Client advised	Outstanding	OH&S REGULATIONS 3.7 AS/NZS 1657-2013 3.3.4

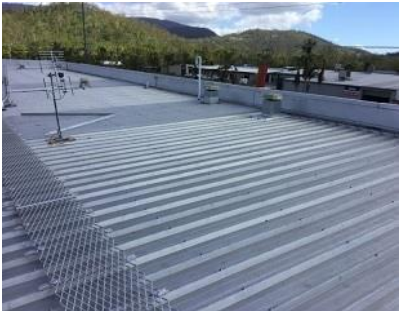
No safe access to the A/c units	Trips, Slips and Falls	N/A	Low	Supply walkway to the A/c units	Low	Client advised	Outstanding	-

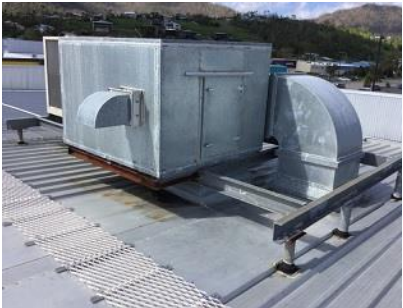
No safe access to the A/c units	Trips, Slips and Falls	Awareness induction	Med	Step bridges and walkway to be installed	Low	Client advised	Outstanding	OH&S REGULATIONS 3.7 AS/NZS 1657-2013 3.1.4

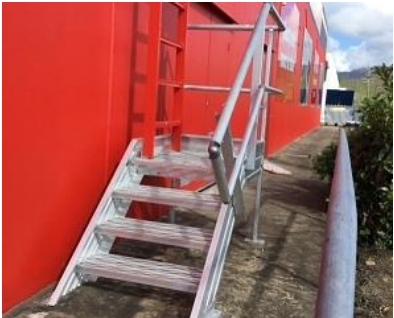
Bottom rung height is less than required minimum	Trips, Slips and Falls	Awareness induction	Med	Existing ladder to be re-install with landing platform, stiles, fittings and fixings	Low	Client advised	Outstanding	OH&S REGULATIONS 3.7 AS/NZS 1657-2013 7.4.3.4

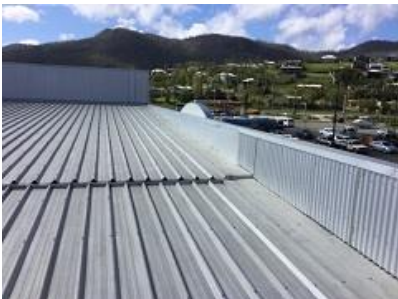
No height safety system installed	Trips, Slips and Falls	Awareness induction	High	Fall arrest anchors to be installed	Low	Client advised	Outstanding	OH&S REGULATIONS 3.55

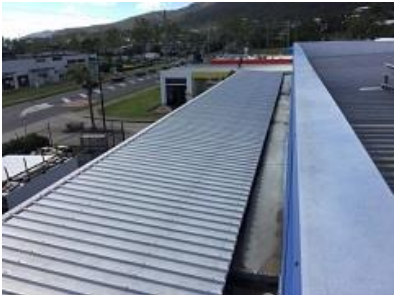
No height safety system installed	Trips, Slips and Falls	Restrict Access	High	"EWP Access Only" sign to be installed	Low	Client advised	Outstanding	OH&S REGULATIONS 3.55 & 3.11

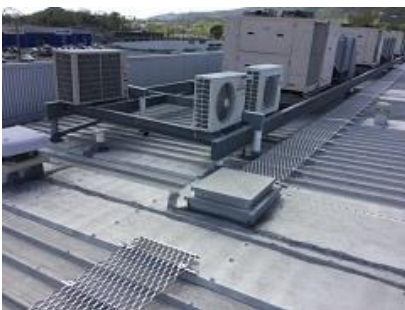
No safe access to the A/c units	Trips, Slips and Falls	N/A	Low	Supply walkway to the A/c units	Low	Client advised	Outstanding	-

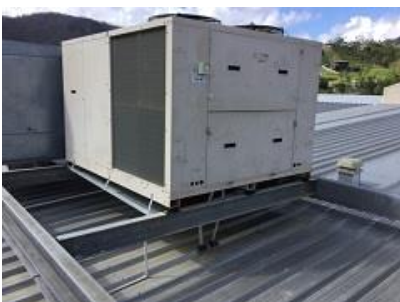
No safe access to the A/c unit	Trips, Slips and Falls	Awareness induction	Med	Step bridge and walkway to be installed	Low	Client advised	Outstanding	OH&S REGULATIONS 3.7 AS/NZS 1657-2013 3.1.4

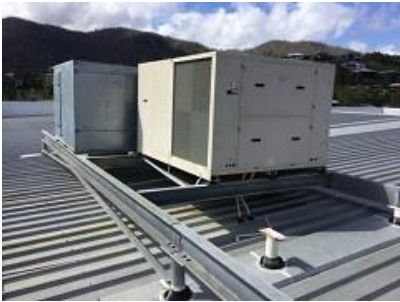
No safe access to the A/c unit	Trips, Slips and Falls	Awareness induction	Med	Step bridge and walkway to be installed	Low	Client advised	Outstanding	OH&S REGULATIONS 3.7 AS/NZS 1657-2013 3.1.4

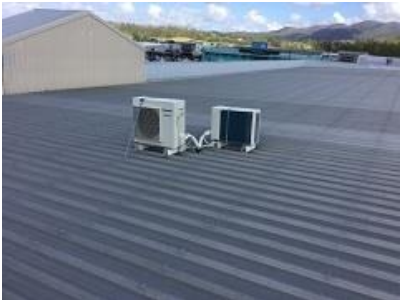
No safe access to the A/c units	Trips, Slips and Falls	N/A	Low	Supply walkway to the A/c units	Low	Client advised	Outsta nding	-

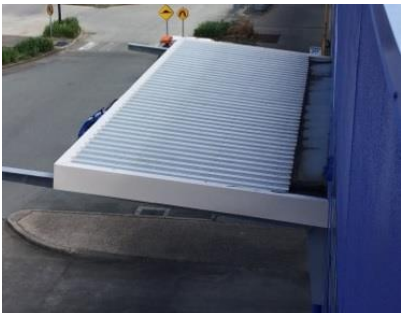
No height safety system installed	Trips, Slips and Falls	Restrict Access	High	"EWP Access Only" sign to be installed	Low	Client advised	Outstanding	OH&S REGULATIONS 3.55 & 3.11

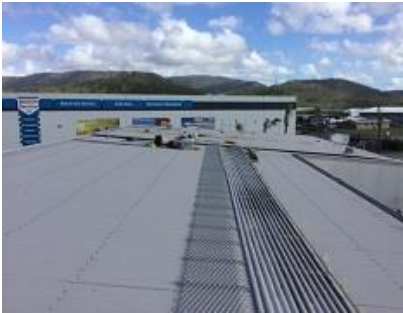
No height safety system installed	Trips, Slips and Falls	Awareness induction	High	Fall arrest anchors to be installed	Low	Client advised	Outstanding	OH&S REGULATIONS 3.55
86	Building: General Stores Location Reference: L77 Task: Access to the A/c unit

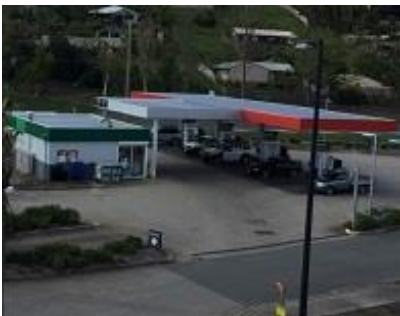
No height safety system installed	Trips, Slips and Falls	Awareness induction	High	Fall arrest anchors, Anchor strop and permanent ladder to be installed	Low	Client advised	Outstanding	OH&S REGULATIONS 3.55 & 3.7 AS/NZS 1657-2013 3.1.4
88	Building: General Stores Location Reference: L80 , L81 & L82 Task: Restrict access to the roof

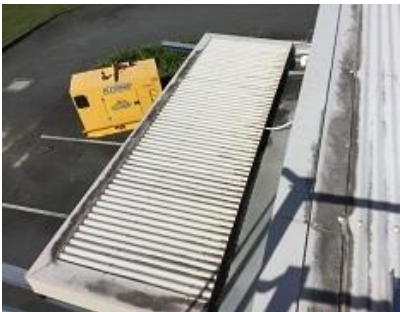
No height safety system installed	Trips, Slips and Falls	Restrict Access	High	"EWP Access Only" signs to be installed	Low	Client advised	Outstanding	OH&S REGULATIONS 3.55 & 3.11

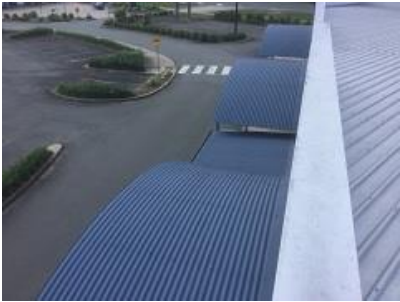
No height safety system installed	Trips, Slips and Falls	Restrict Access	High	"EWP Access Only" sign to be installed	Low	Client advised	Outstanding	OH&S REGULATIONS 3.55 & 3.11
90	Building: General Stores Location Reference: L84 Task: Restrict access to the roof

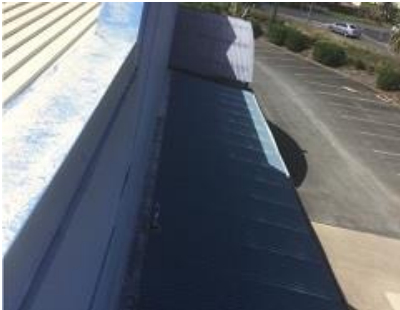
No height safety system installed	Trips, Slips and Falls	Restrict Access	High	"EWP Access Only" sign to be installed	Low	Client advised	Outstanding	OH&S REGULATIONS 3.55 & 3.11

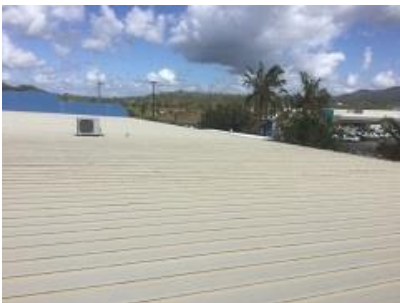
No height safety system installed	Trips, Slips and Falls	Awareness induction	High	Ladder access bracket, Anchor strop, Fall arrest anchor and signage to be installed	Low	Client advised	Outstanding	OH&S REGULATIONS 3.55
92	Building: General Stores Location Reference: L86 Task: Access to the A/c units

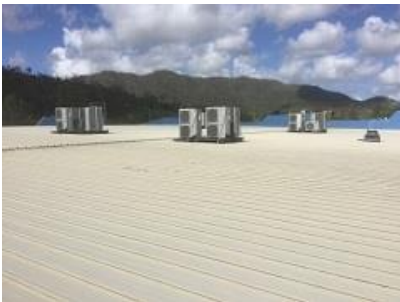
No safe access to the A/c units	Trips, Slips and Falls	N/A	Low	Supply walkway to the A/c units	Low	Client advised	Outstanding	-

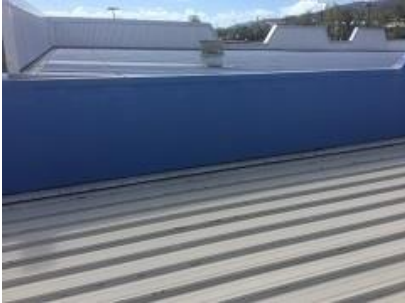
Variation in height between roofs are greater than required maximum	Trips, Slips and Falls	Awareness induction	Med	Access ladder including handrails to be installed	Low	Client advised	Outstanding	OH&S REGULATIONS 3.7 AS/NZS 1657-2013 3.1.4
